**HAZARDOUS MATERIALS REGISTER AND ASBESTOS
MANAGEMENT PLAN
RED CROSS SITE
114 NEWDEGATE STREET,
GREENSLOPES QLD 4120**

Prepared for: Department of Veteran Affairs
Legal Advising and Dispute Resolution
Project Ref: ENAURHOD06233AA
Report Date: 12 August 2013

**RE: Report - Hazardous Materials Register and Management Plan for the Red Cross Hostel,
114 Newdegate Street, Greenslopes Qld 4120**

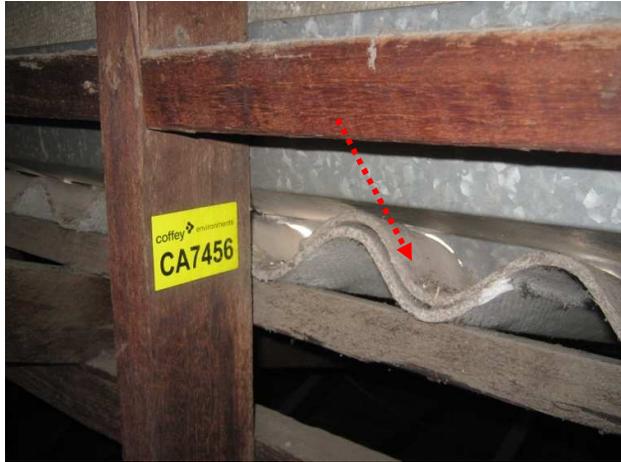
Photograph 1: External: Ground level, Roof cladding – North side lower roof section; Roof cladding. Corrugated asbestos cement sheets.

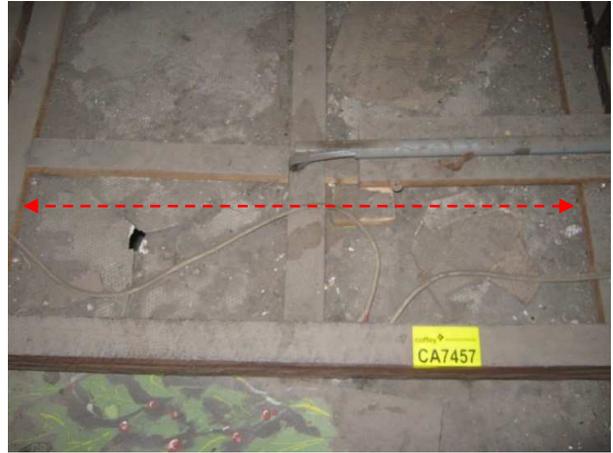
Photograph 2: Internal: Level 1, North side Stage – Fire stairs; Ceiling lining. Damaged asbestos cement sheet. (Please refer to Sample CA 7457)

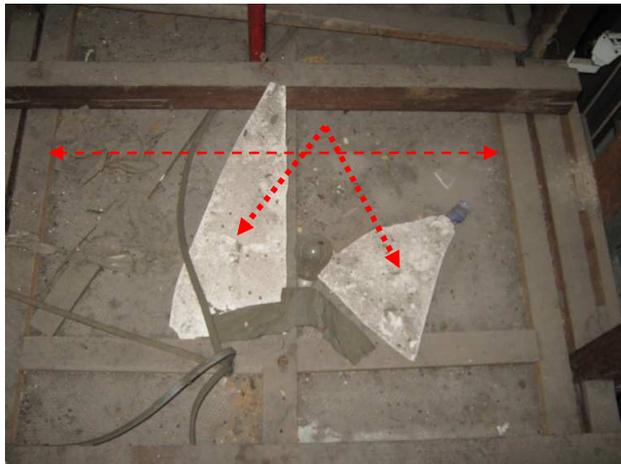
Photograph 3: Internal: Level 1, South side Stage – Fire stairs; Above ceiling lining. Asbestos cement fragments (wall lining) and asbestos ceiling lining.

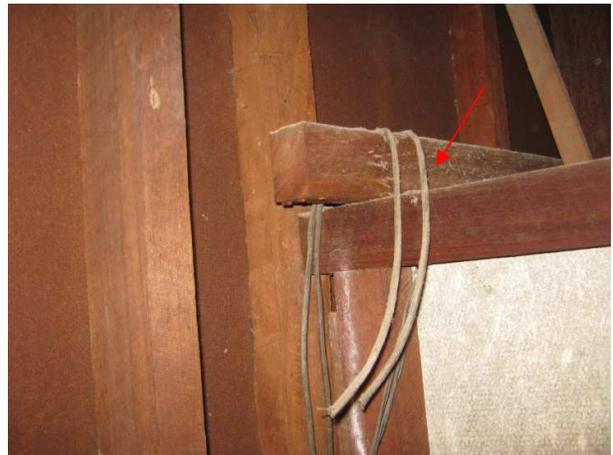
Photograph 4: Internal: Level 1, North side Stage area – Rostrum; Hanging wiring with suspected asbestos cloth insulation.

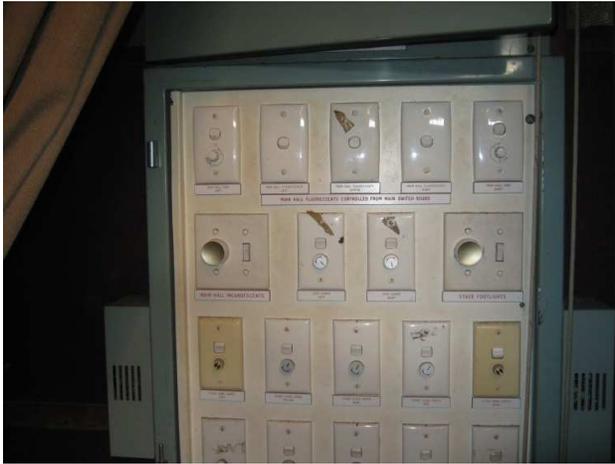
Photograph 5: Internal: Level 1, South side Stage area – Main Switchboard and D.B; Suspect 'Zelemite' E.M.B support.

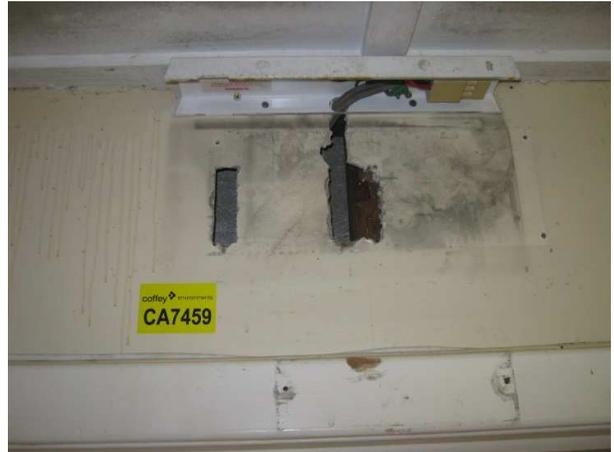
Photograph 6: Internal: Level 1, South side First Aid / Meeting room – South wall lining (Midway). Damaged asbestos cement lining. (former EXIT sign)

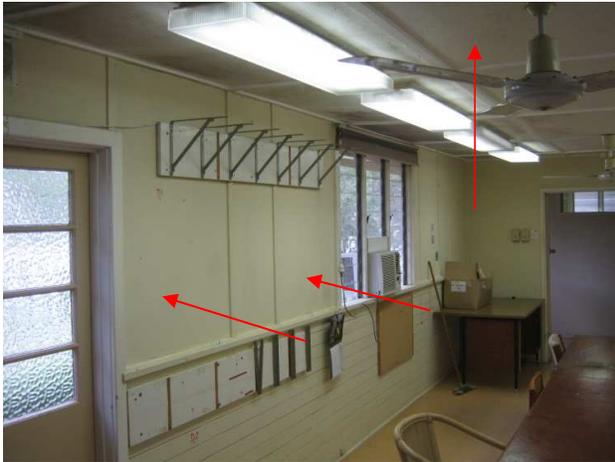
Photograph 7: Internal: Level 1, South side First Aid / Meeting room – South side wall lining and ceiling lining.

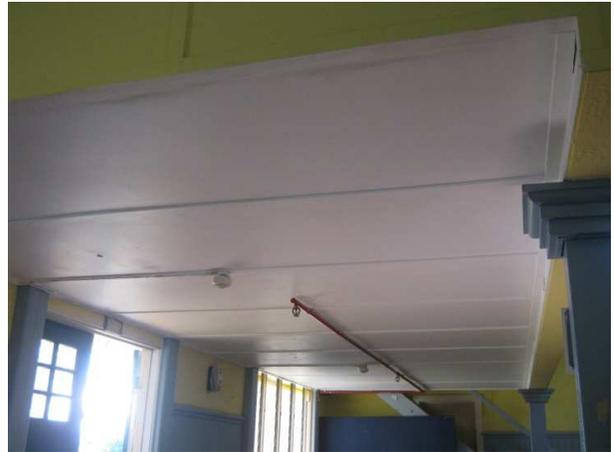
Photograph 8: Internal: Level 1, Mezzanine Cinema room – Under-croft ceiling lining. Asbestos cement sheets.

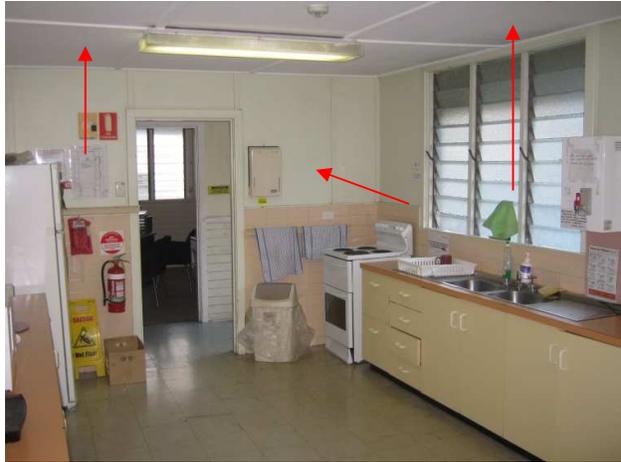
Photograph 9: Internal: Level 1, North side Red Cross Kitchen – Ceiling and wall lining. Asbestos cement sheeting. Please refer to samples CA 7462 and CA 7460

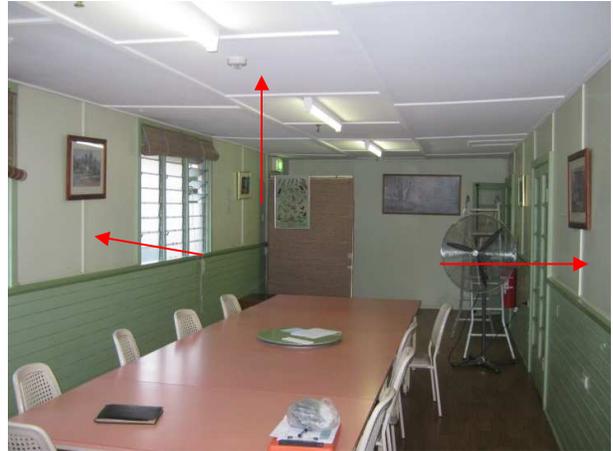
Photograph 10: Internal: Level 1, North side Red Cross Dining / staff room – Ceiling and wall lining. Asbestos cement sheeting. Please refer to samples CA 7462 and CA 7460

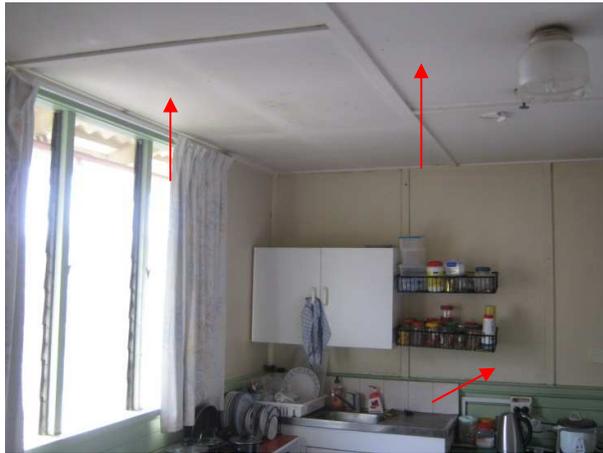
Photograph 11: Internal: Level 1, North side Caretakers accommodation – Kitchen; Asbestos cement ceiling and wall lining.

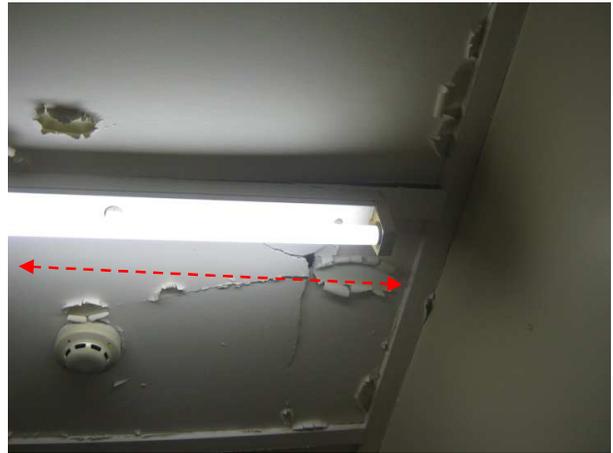
Photograph 12: Internal: Level 1, North side Caretakers accommodation (supervisor) – Storage closet; Damaged ceiling sheet.

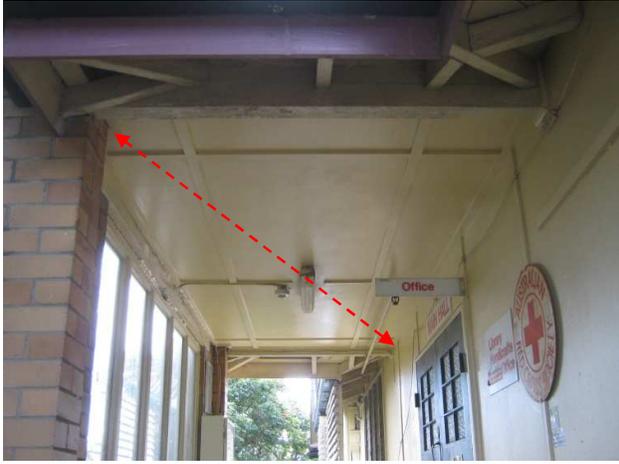
Photograph 13: External: Main Hall building; Western side entrance – Awning lining (asbestos cement sheets)

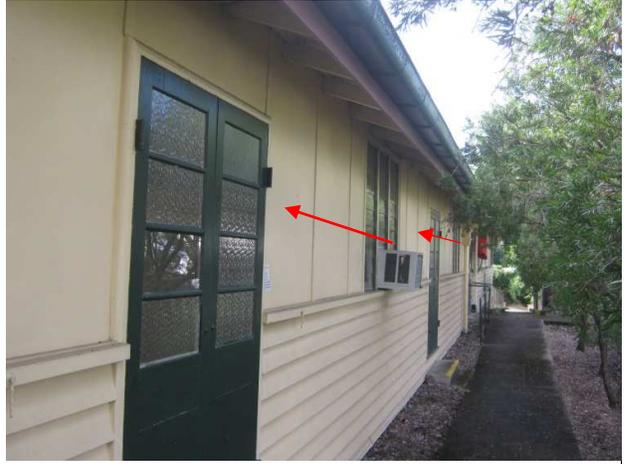
Photograph 14: External: Main Hall building; South side (level 1) – Asbestos cement wall cladding sheets

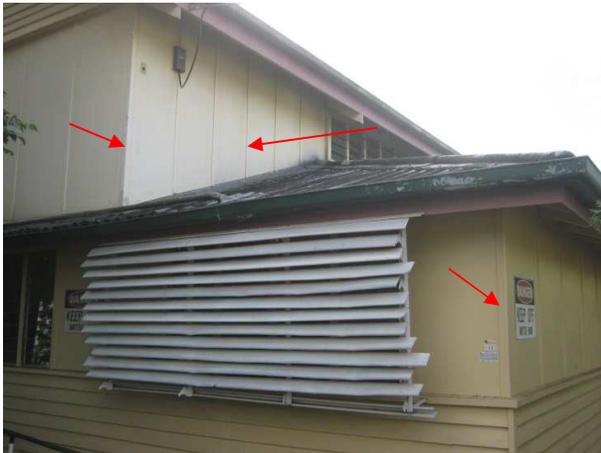
Photograph 15: External: Main Hall building; East side (level 1) – Wall battens and corner guards

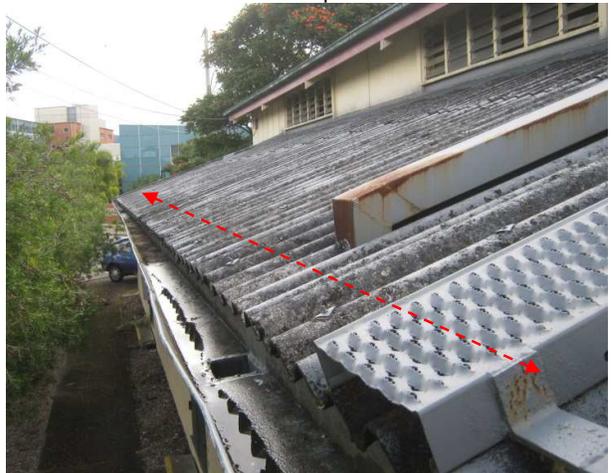
Photograph 16: External: Main Hall building, Level 1; South side lower roof – Roof cladding sheets; Corrugated asbestos cement. Refer to sample CA 7474

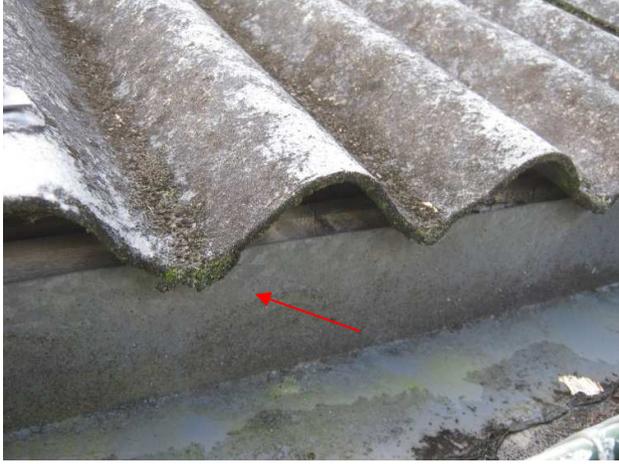
Photograph 17: External: Main Hall building, Level 1; South side lower roof – Roof cladding sheets; Corrugated asbestos cement weathered with ACD 'beards' at perimeter sheets.

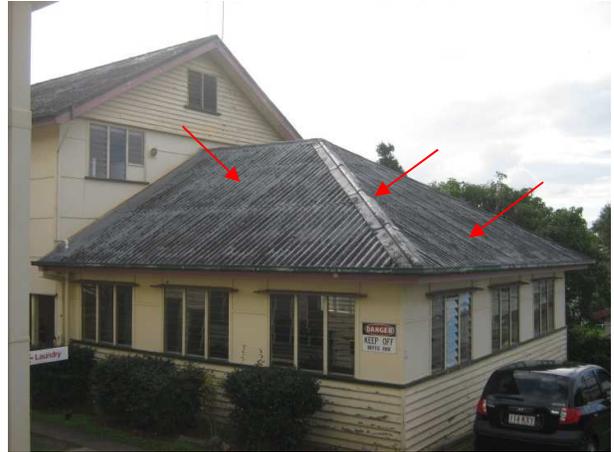
Photograph 18: External: Ground level, East side roof top; Annexe – Corrugated asbestos cement roof cladding sheets and ridge capping.

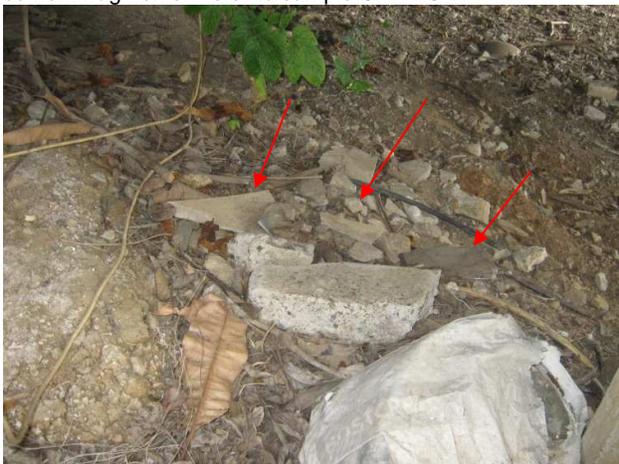
Photograph 19: Accommodation building, Ground level sub-floor area – Below north west side stairs; Asbestos cement fragments. Refer to sample CA7478

Label/sign locations and recommendations			Leave, label and maintain. Regular re-inspections required														
Refer to CA 7477	CH	20	Corrugated asbestos cement fragments	Accommodation building, Ground level sub-floor area – Below north west side stairs; Asbestos cement fragments (corrugated)	N	1	1	3	3	2	2	3	3	1 8	A 2	X2	Please note: Asbestos fragments may potentially be buried within the soil. Fragments observed at surface within 2.0m of bld perimeter

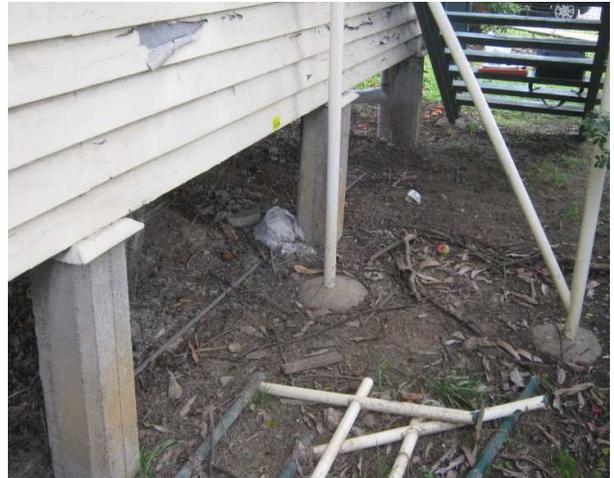
Photograph 20: Accommodation building, Ground level sub-floor area – Below north west side stairs;

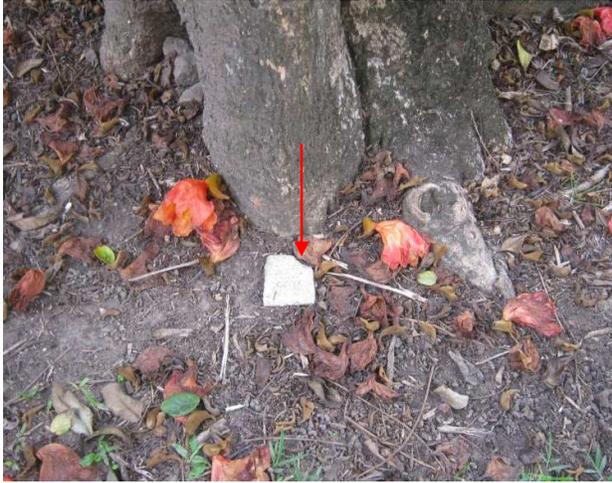
Photograph 21: Accommodation building, Ground level
– At the base of the north west side 'African tulip' tree;
Asbestos cement sheet fragment.

Label/sign locations and recommendations			Damaged cladding sheet fragment. Requires removal by a licensed removal contractor. - Periodic inspections required.														
CA7471	CH	-	Asbestos cement sheets	Internal: Ground level , Corridor / Bedrooms 14 & 15 – West side wall lining	N	1	1	0	0	1	0	0	1	4	A4	<25 m ²	
Refer to CA7471	CH	-	Asbestos cement sheets	Internal: Ground level , Linen room – East side wall lining (common wall to accommodation side)	N	1	1	0	0	1	0	0	1	4	A4	<25 m ²	
V.O	Suspect	-	'Tilux' Asbestos	Internal: Ground level – Linen store	N	3	1	0	1	1	0	0	1	7	A	<1 m ²	Laminated high density

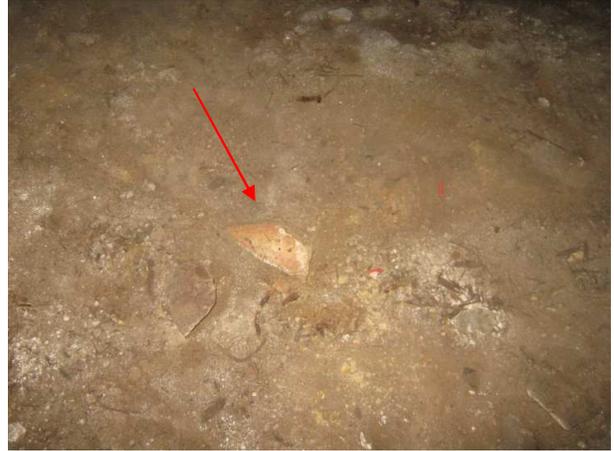
Photograph 22: External: Ground level, Main hall building
– Central sub-floor area opposite workshop;
Asbestos cement fragments found at ground surface.

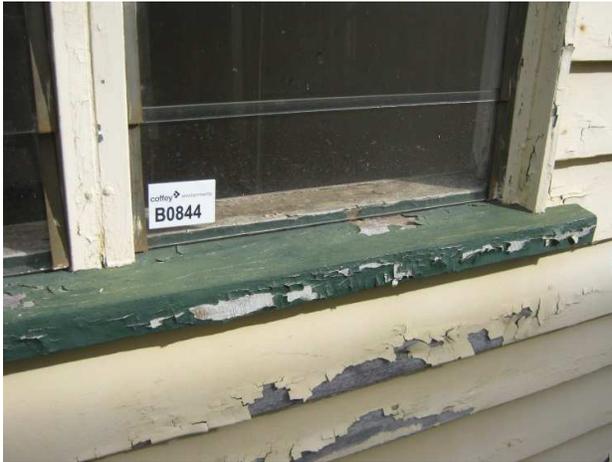
Photograph 23: External: Main Hall building; Ground level, north side windows – Timber frame rail (horizontal):
Lead-based paint, Refer to paint sample BO844

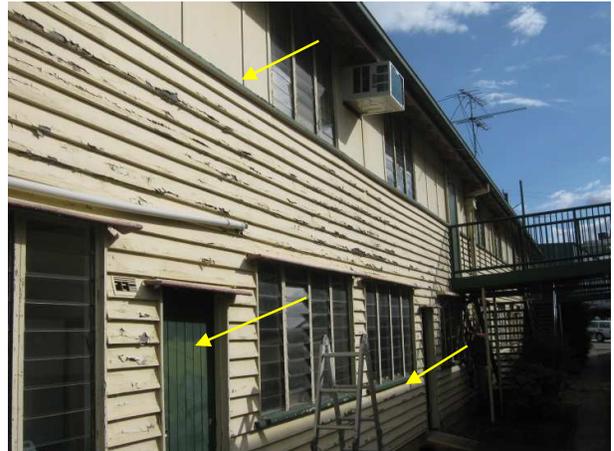
Photograph 24: External: Main Hall building; Ground level, north side windows – Timber frame rail (horizontal);
and doors (x2), Lead-based paint system

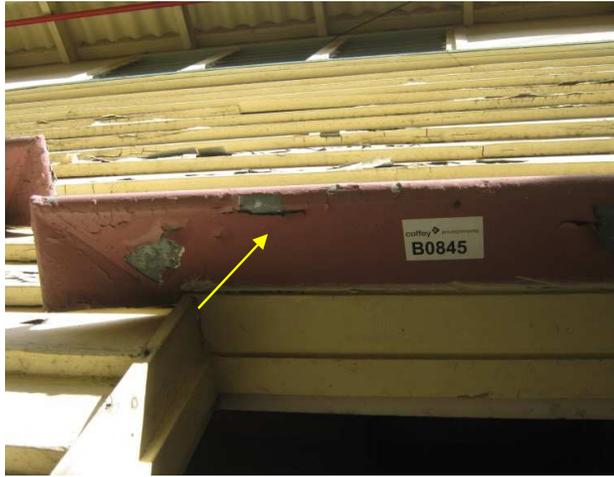
Photograph 25: External: Main Hall building; Ground level, north side windows – Metal window shades. Lead-based paint

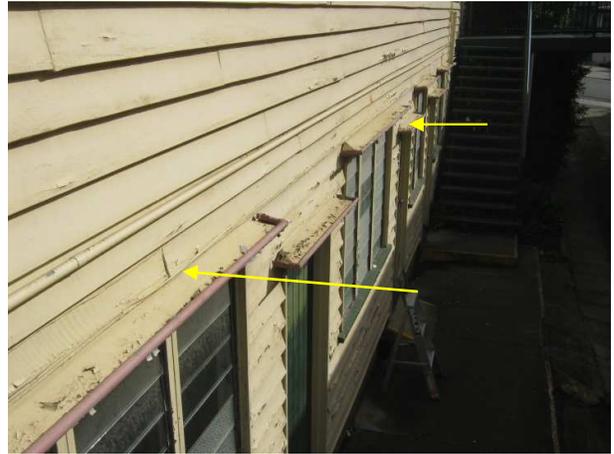
Photograph 26: External: Main Hall building; Ground level, north side windows and doors – Metal window shades. Refer to paint sample B0845, Lead-based paint.
