**Asbestos Management  
Plan and Register for  
114 Newdegate Street  
Greenslopes**

Our Reference 019DVA01

**13 October 2019**

We are pleased to be able to supply you with the Asbestos Management Plan and Register of our inspection of 114 Newdegate Street Greenslopes

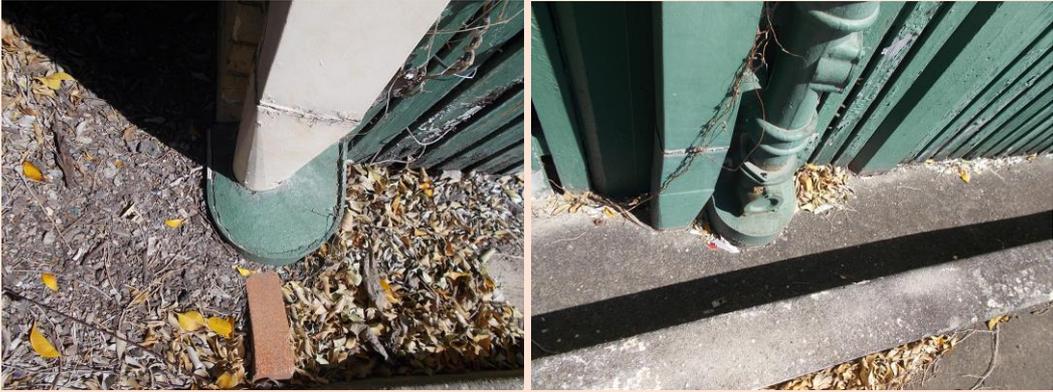
<b>Image 1: External drain surrounds are asbestos cement.</b>

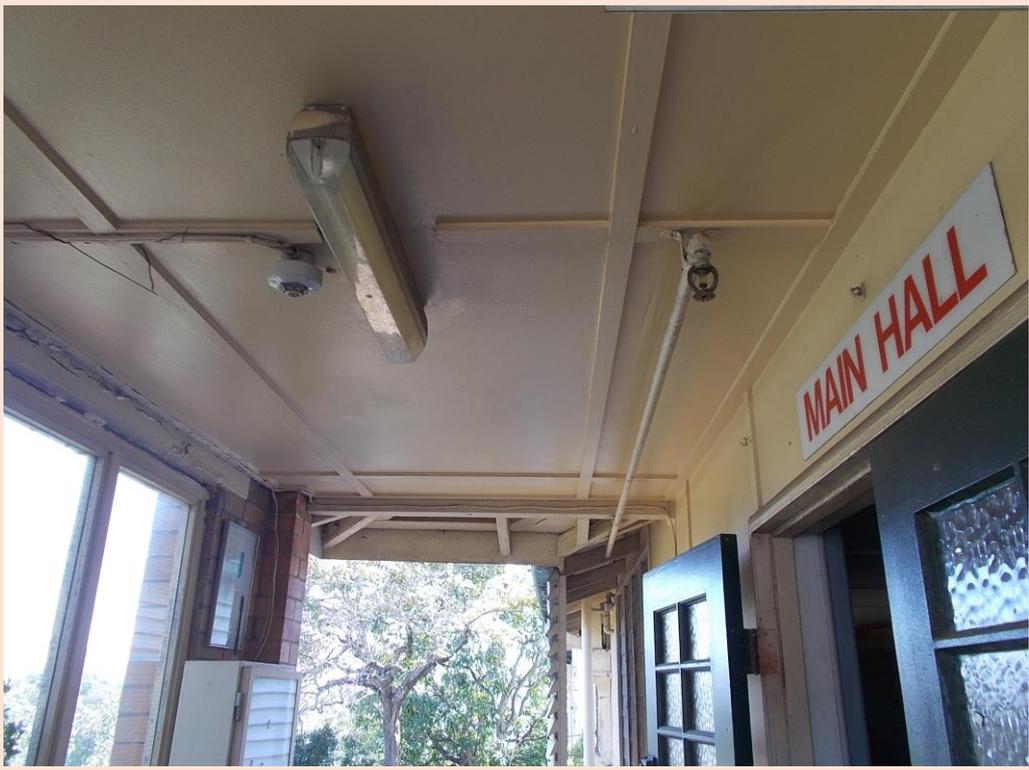
**Image 2: Front verandah entrance ceiling is lined in asbestos cement sheet.**

**Recommendations** Avoid damage and abrasion. Remove if dismantling, structural alterations or demolition is to be carried out in this area. Reassess at least every five years or prior to renovation or demolition work. Label appropriately as per State Government Guidelines and the Code of Practice.

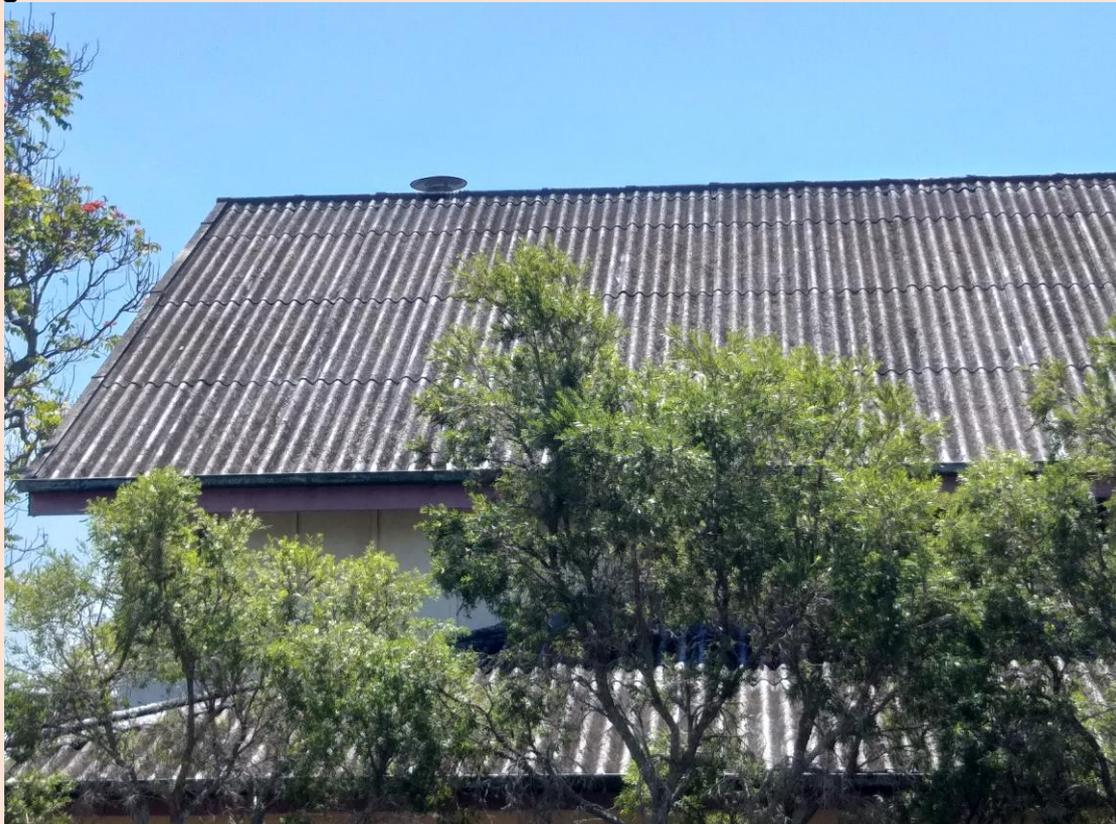
**Comments** The roof cladding is corrugated asbestos cement sheeting this includes the edge and ridge capping. It was sealed in 2009 the sealant deteriorated rapidly and hailstorms have pockmarked all the sheeting releasing additional asbestos from the mainly friable top surfaces.

**Image 3: Steep pitch corrugated asbestos cement roof cladding.**

**Recommendations** Avoid further damage and abrasion. **Plan for removal and replacement of the roof as soon as practicable.** This will need to include site decontamination and roof/ ceiling space contamination. Remove if dismantling, structural alterations or demolition is to be carried out in this area.

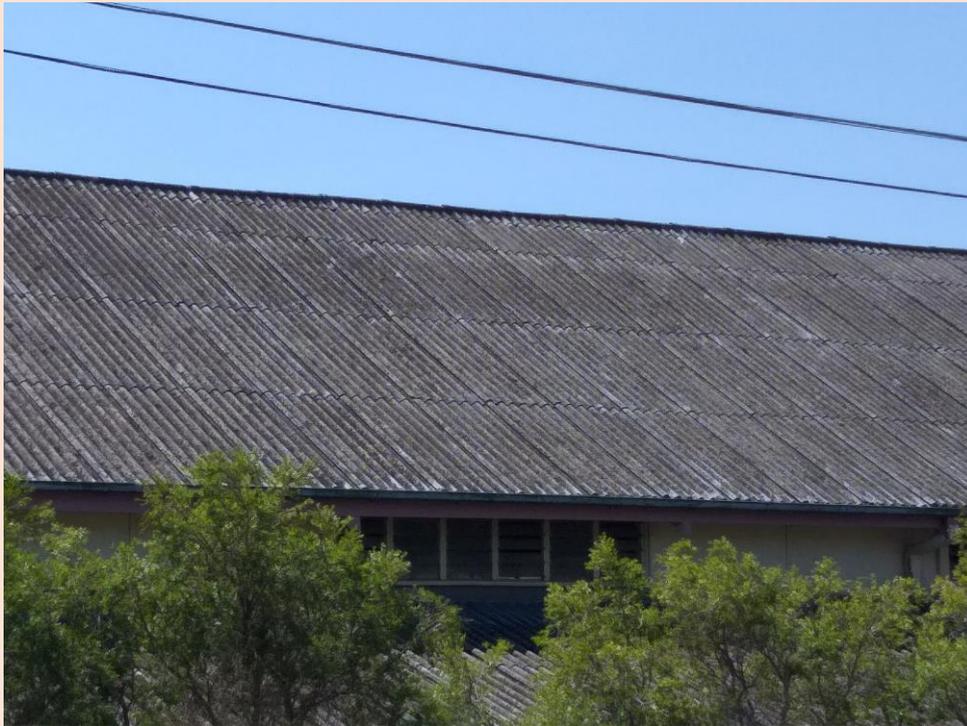
**Image 4: The steep pitch means that asbestos released from the deteriorating roof washes down into the gutter and over it.**

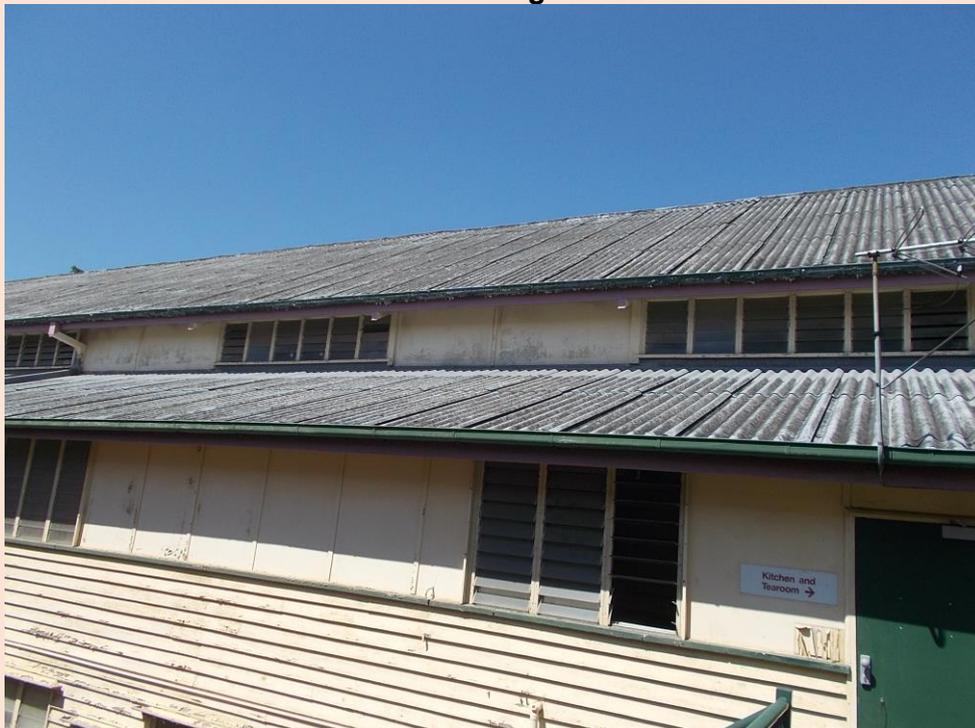
**Image 5: Both levels of roof cladding show similar deterioration.**

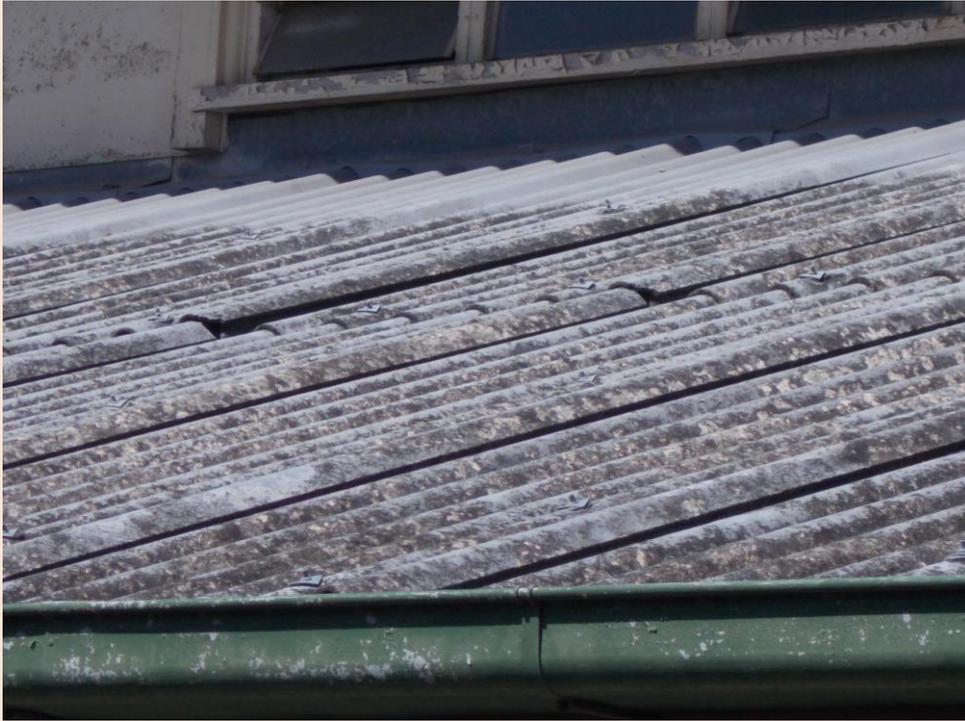
**Image 6: Some of the sealant still remains where it's not as exposed to the weather but as can be seen the rest of the roof cladding is in poor condition.**

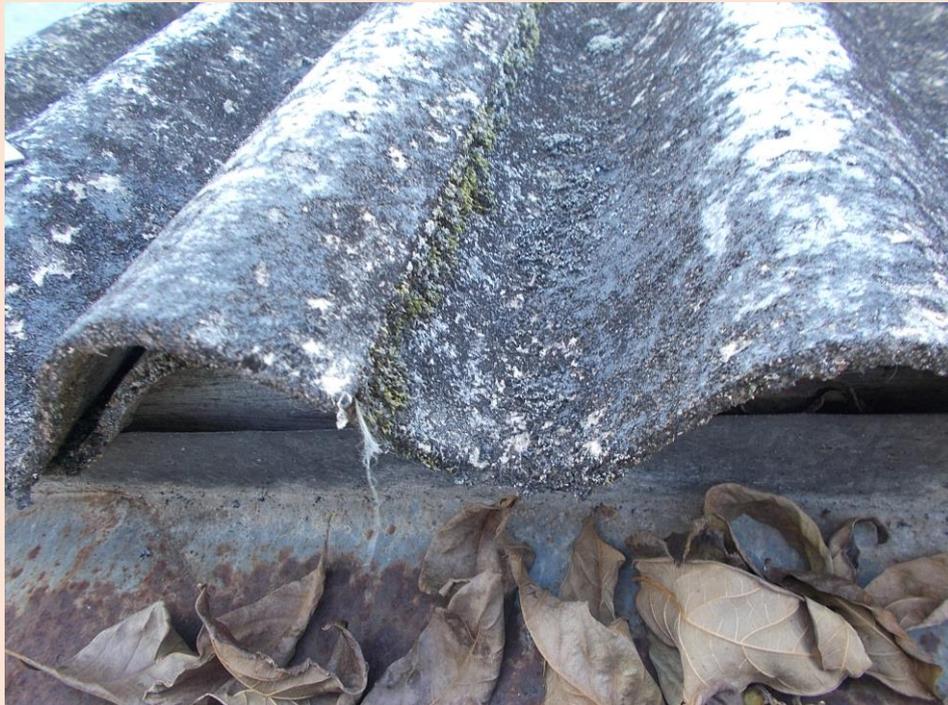
**Image 7: Closer view showing the deteriorated surface asbestos build-up in the dips of the corrugations before being washed off.**

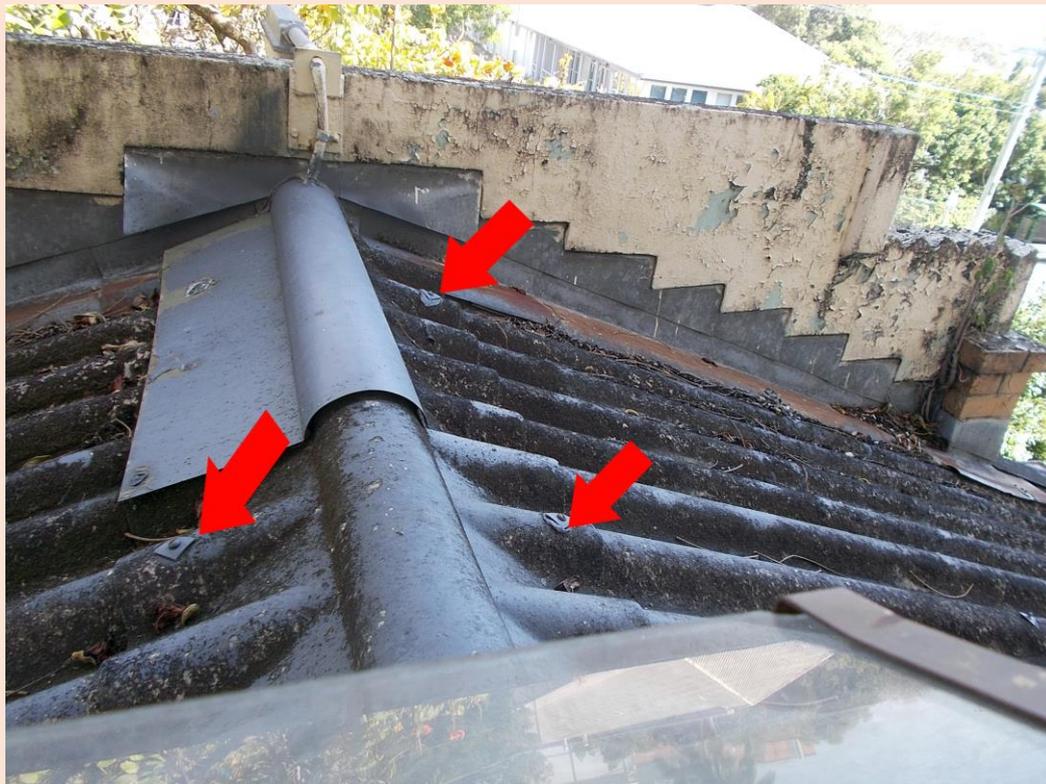
**Image 8: The black sealant (painted grey) used to waterproof around the roofing nails contains asbestos.**

**Recommendations** Avoid further damage and abrasion. Plan for removal and replacement of the roof which will include the clout sealant

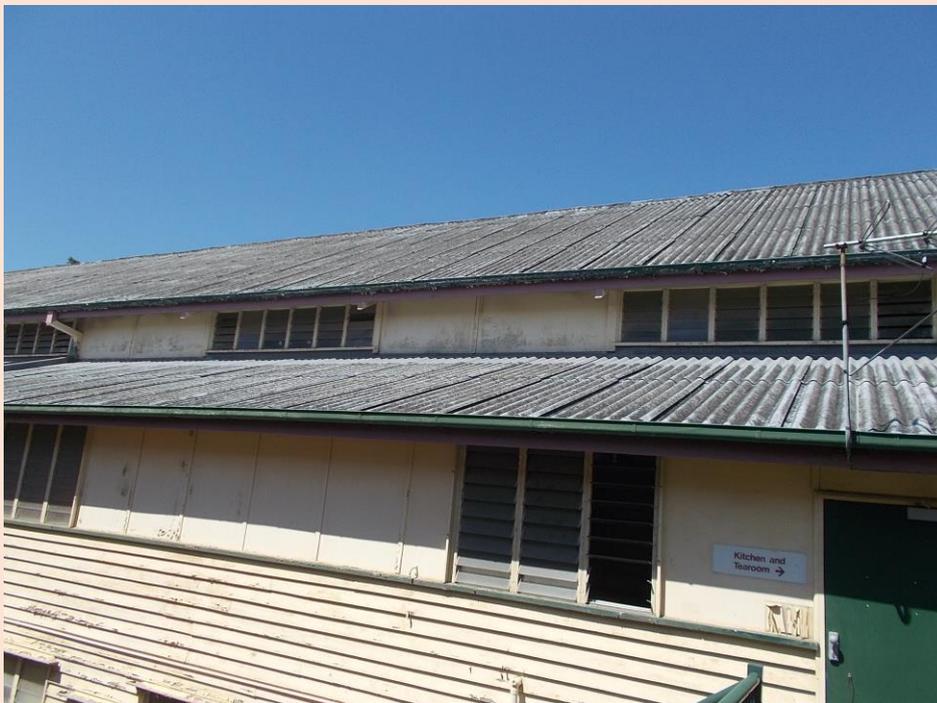
**Image 9: Asbestos cement wall cladding around the perimeter of the building.**

**Recommendations** Avoid damage and abrasion. Remove if dismantling, structural alterations or demolition is to be carried out in this area. Reassess at least every five years or prior to renovation or demolition work. Label appropriately as per State Government Guidelines and the Code of Practice.

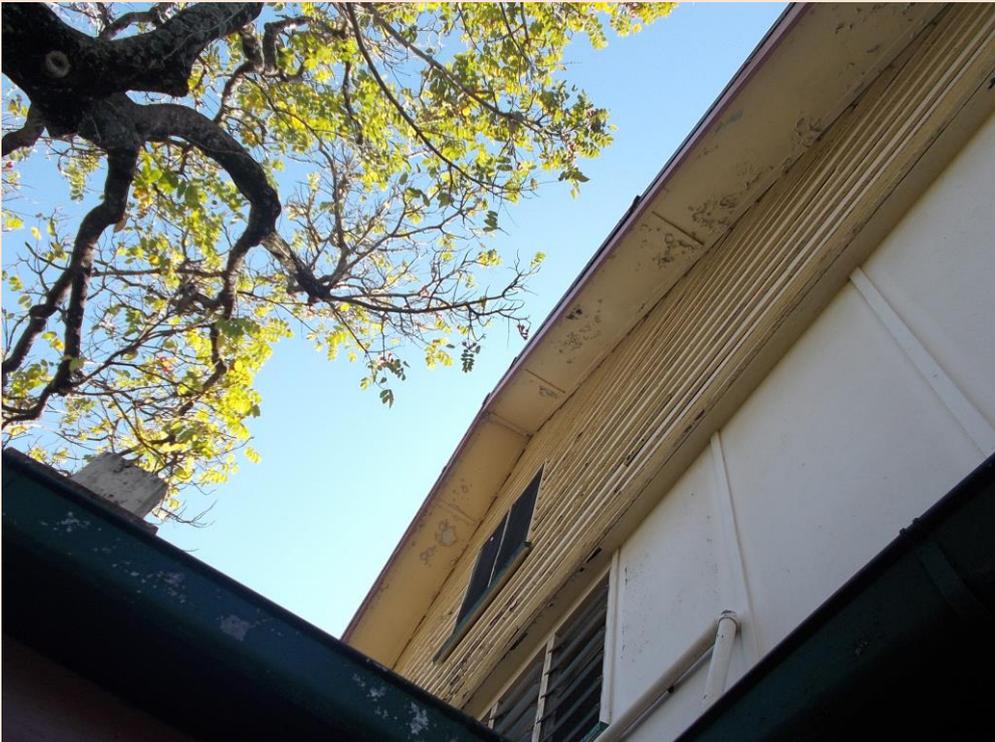
**Image 10: The external upper eaves (under the end pitched rooves) are lined in asbestos cement sheeting.**

**Recommendations** Avoid damage and abrasion. Remove if dismantling, structural alterations or demolition is to be carried out in this area. Reassess at least every five years or prior to renovation or demolition work. Label appropriately as per State Government Guidelines and the Code of Practice.

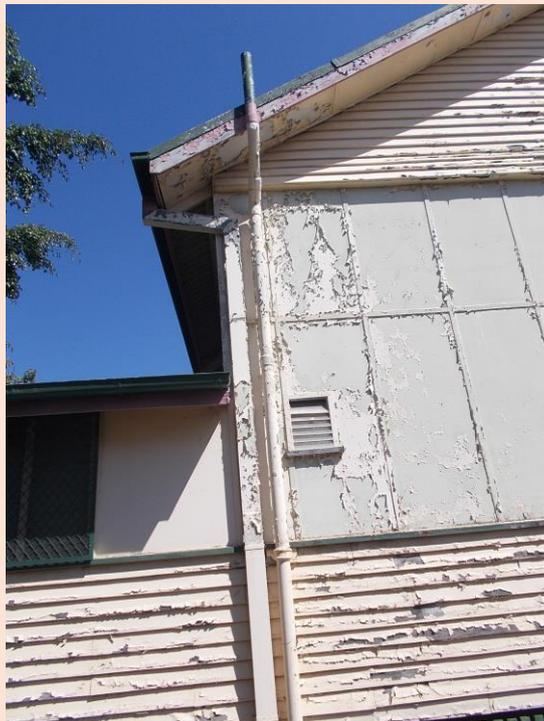
**Image 11: The sewerage vent pipe extending up from the ground at the rear of the Main Hall Building has an asbestos cement pipe upper section.**

**Recommendations** Avoid damage and abrasion. Remove if dismantling, structural alterations or demolition is to be carried out in this area. Reassess at least every five years or prior to renovation or demolition work. Label appropriately as per State Government Guidelines and the Code of Practice.

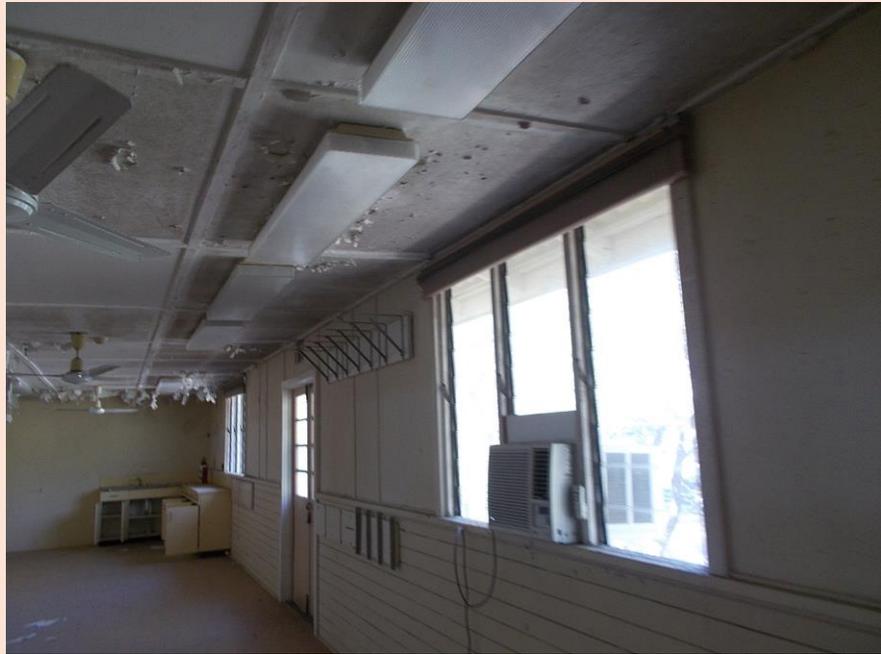
**Image 12: The walls and ceilings to all the lower ceiling areas on both sides and rear of the Hall itself including the two Units are lined in asbestos cement sheeting.**

**Recommendations** Avoid damage and abrasion. Remove if dismantling, structural alterations or demolition is to be carried out in this area. Reassess at least every five years or prior to renovation or demolition work. Label appropriately as per State Government Guidelines and the Code of Practice.

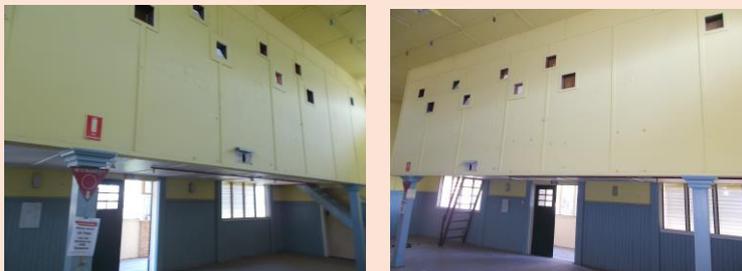
**Image 13: Projector Room: Outer wall and underside ceiling lined in asbestos cement sheeting.**

**Recommendations** **Avoid further damage and abrasion. Repair seal or remove damaged panel.** Remove if dismantling, structural alterations or demolition is to be carried out in this area. Reassess at least every five years or prior to renovation or demolition work. Label appropriately as per State Government Guidelines and the Code of Practice.

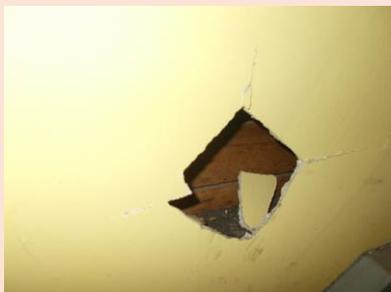
**Image 14: Damaged wall panel on the West Staircase.**

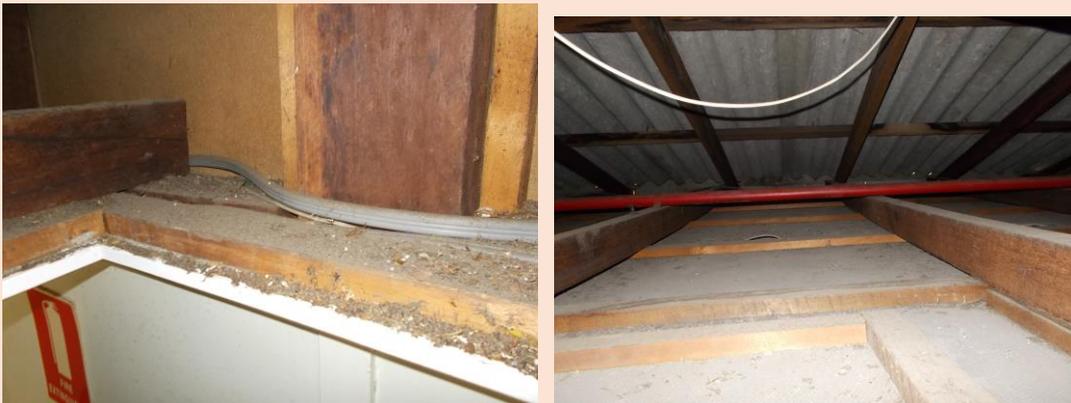
**Image 15: Former Kitchen Lunchroom ceiling space this year (2019) where a sample (DV – 01) was taken this was positive for asbestos.**

**Recommendations** Avoid further damage and abrasion. **Ensure appropriate PPE and procedures are in place when working in the upper areas of the buildings especially in confined ceiling or upper structural areas close to the new roof cladding.**  
Label appropriately as per State Government Guidelines and the Code of Practice.

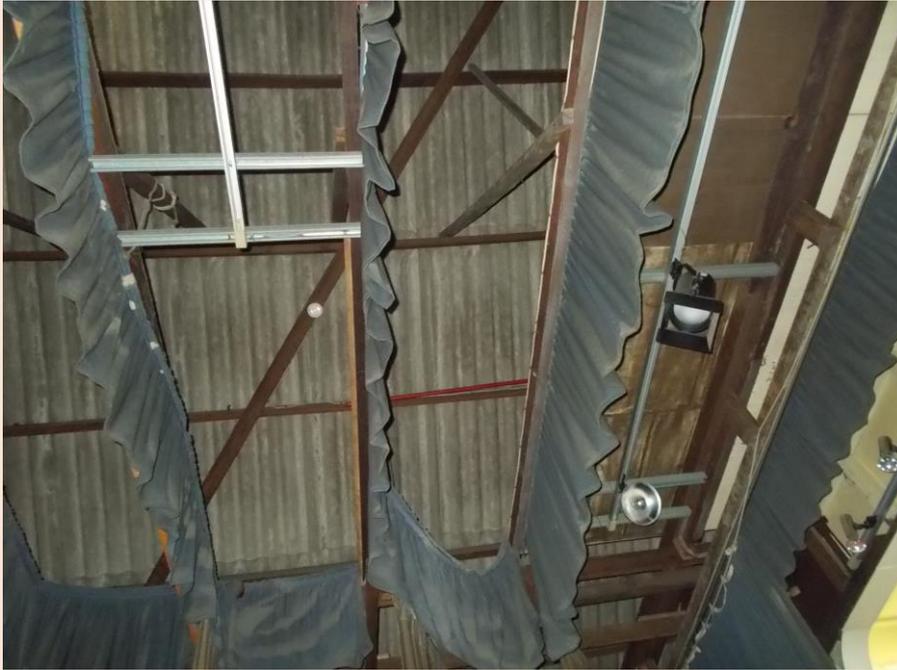
**Image 16: Open ceiling space to the corrugated asbestos cement roof behind the Stage**

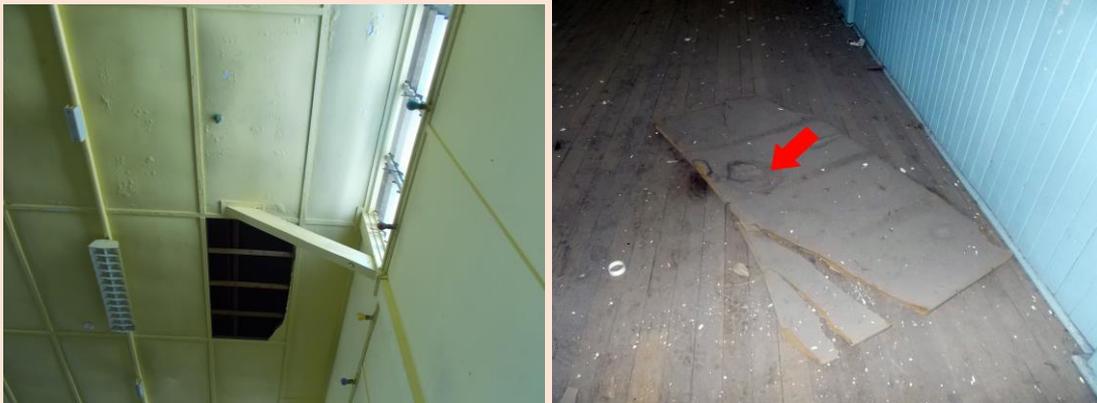
**Image 17: It should be expected that upper structural supports and beams will be contaminated with asbestos that has gradually released over decades from the former asbestos cement roof cladding. Even a wooden ceiling panel which had fallen to the floor and been sitting there for a number of years was found to be contaminated on its top surface (sample DV – 02)**

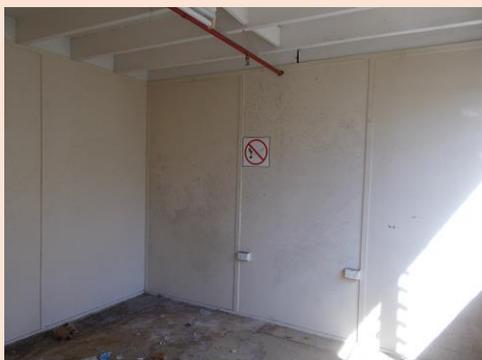
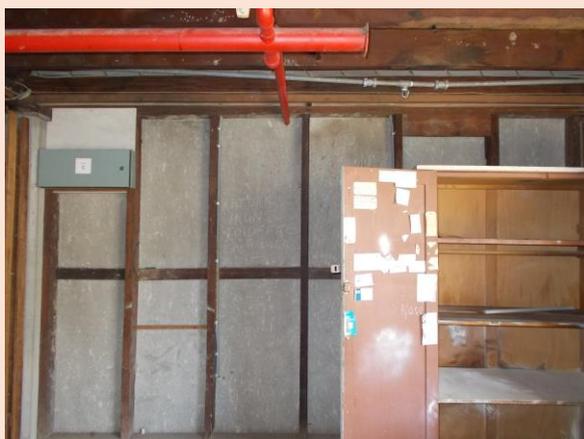
**Image 18: Downstairs rooms showing the asbestos cement sheet used for the walls.**

**Recommendations** Avoid damage and abrasion. Remove if dismantling, structural alterations or demolition is to be carried out in this area. Reassess at least every five years or prior to renovation or demolition work. Label appropriately as per State Government Guidelines and the Code of Practice.

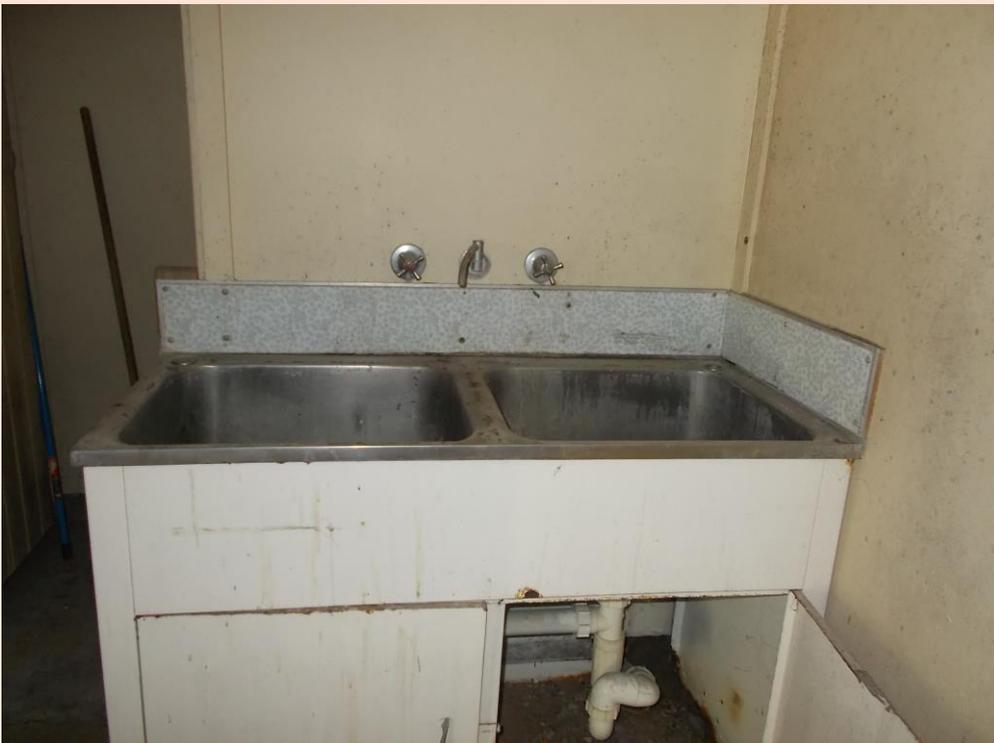
**Image 19: The sink backing panels are constructed of laminated asbestos cement sheeting.**

**Recommendations** Avoid damage and abrasion. Remove if dismantling, structural alterations or demolition is to be carried out in this area. Reassess at least every five years or prior to renovation or demolition work. Label appropriately as per State Government Guidelines and the Code of Practice.

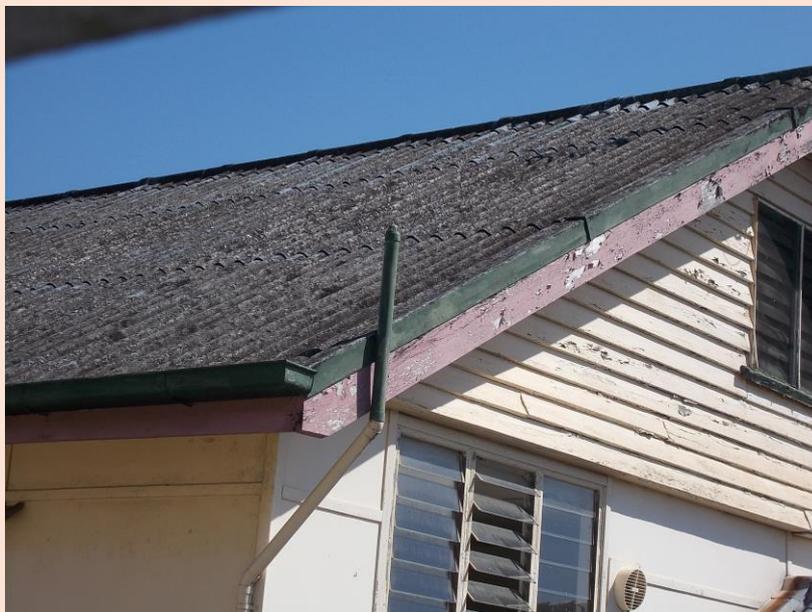
Image 20: The roof cladding is corrugated asbestos cement sheeting.

**Recommendations** Avoid further damage and abrasion. **Plan for removal and replacement of the roof as soon as practicable.** This will need to include site decontamination and roof/ ceiling space contamination. Remove if dismantling, structural alterations or demolition is to be carried out in this area.

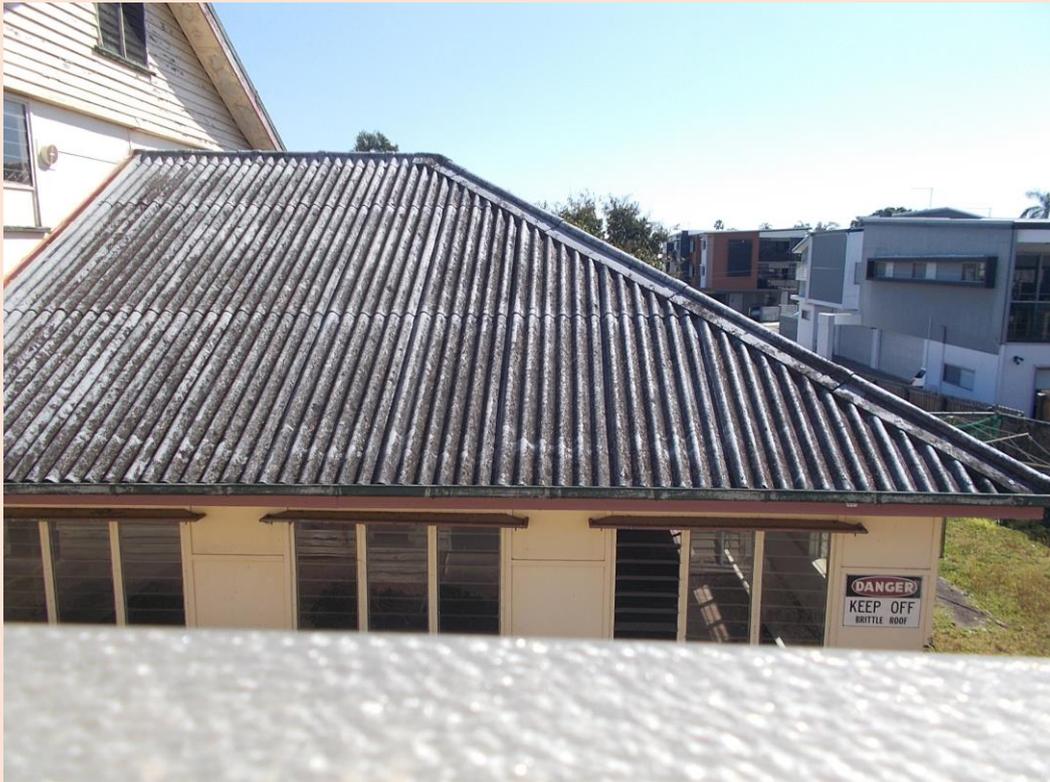
**Image 21: Lower rear area of corrugated asbestos cement sheet roof cladding**

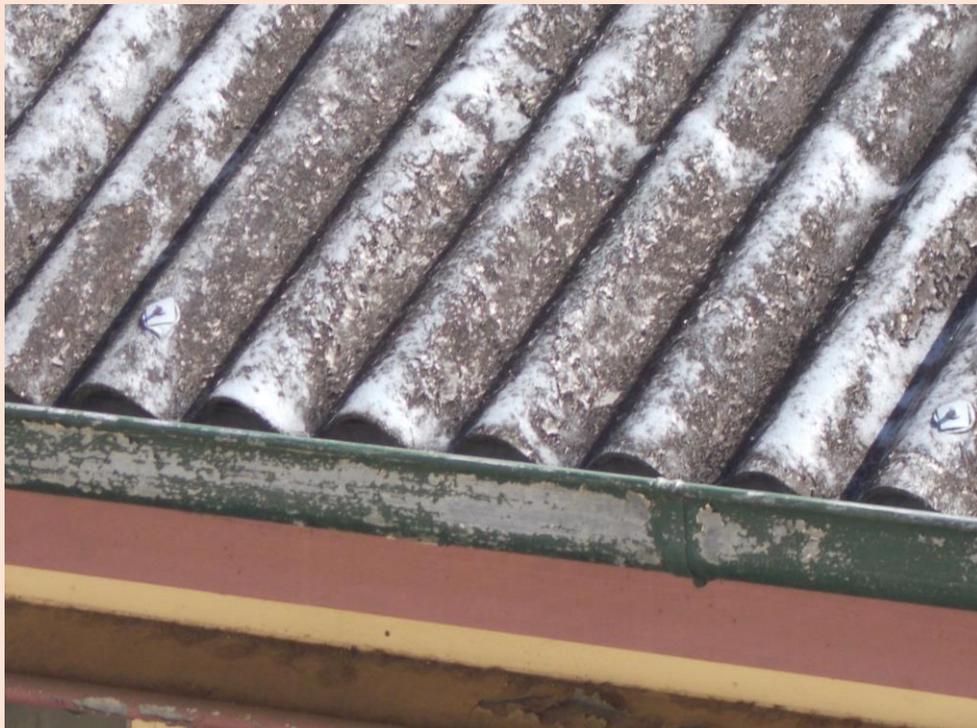
**Image 22: Closer view showing pock marks from hail**

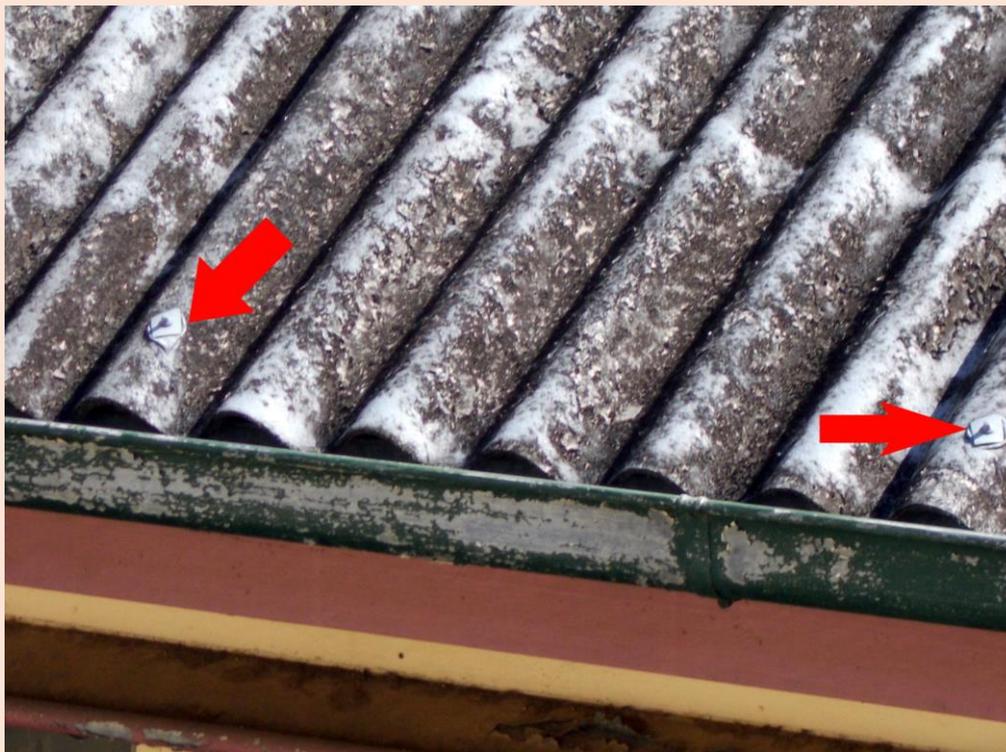
**Image 23: The black sealant (painted grey) used to waterproof around the roofing nails contains asbestos.**

**Recommendations** Avoid further damage and abrasion. Plan for removal and replacement of the roof which will include the clout sealant

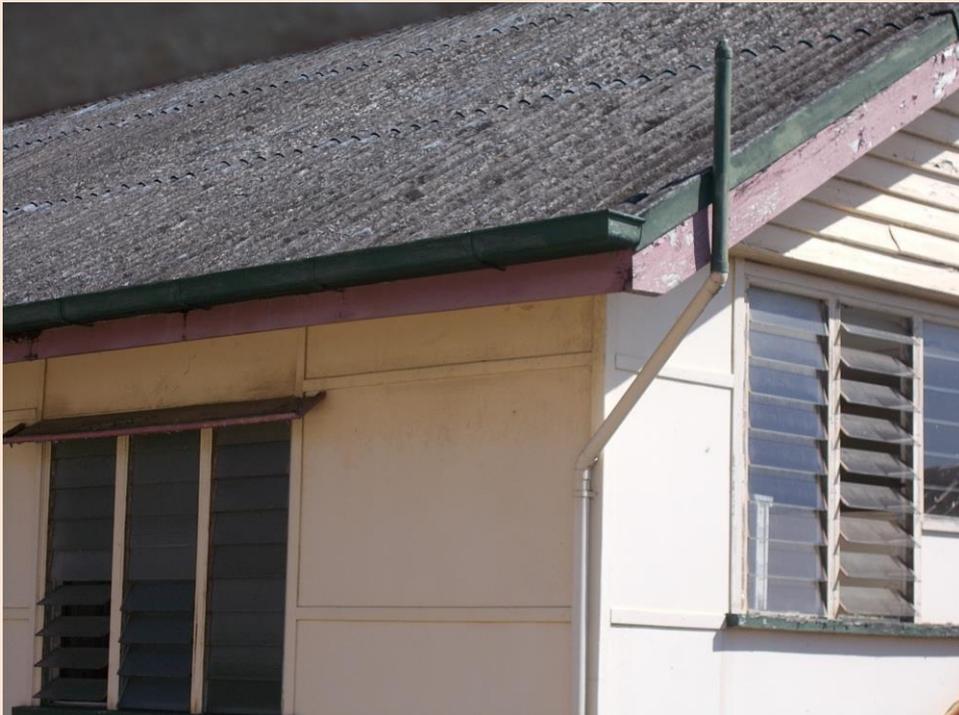
**Image 24: The main walls to the outside of the building are clad in asbestos cement sheeting.**

**Recommendations** Avoid damage and abrasion. Remove if dismantling, structural alterations or demolition is to be carried out in this area. Reassess at least every five years or prior to renovation or demolition work. Label appropriately as per State Government Guidelines and the Code of Practice.

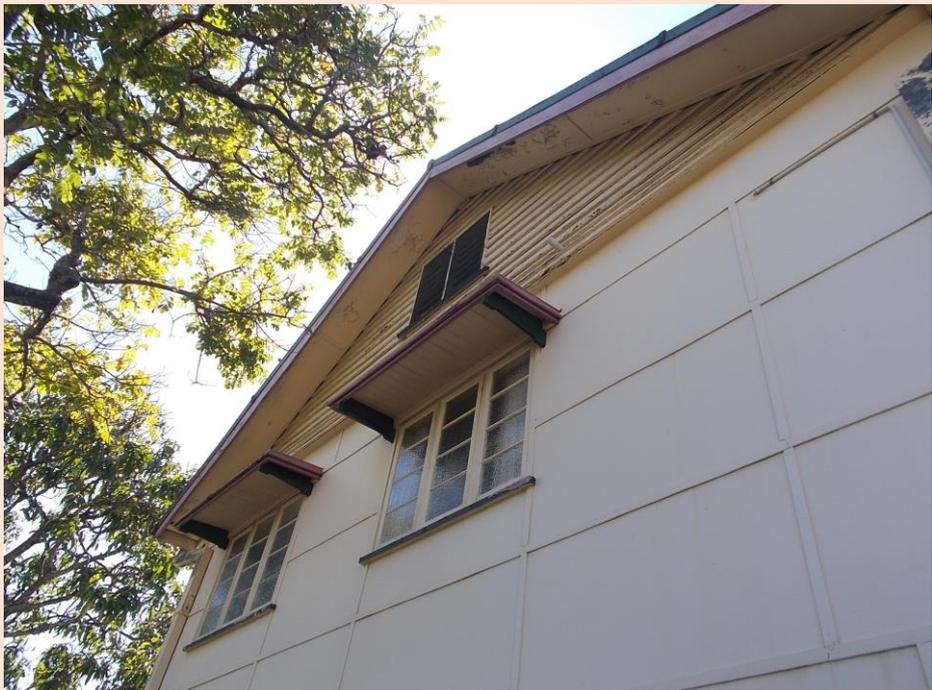
**Image 25: The external upper eaves (under the end pitched rooves) are lined in asbestos cement sheeting.**

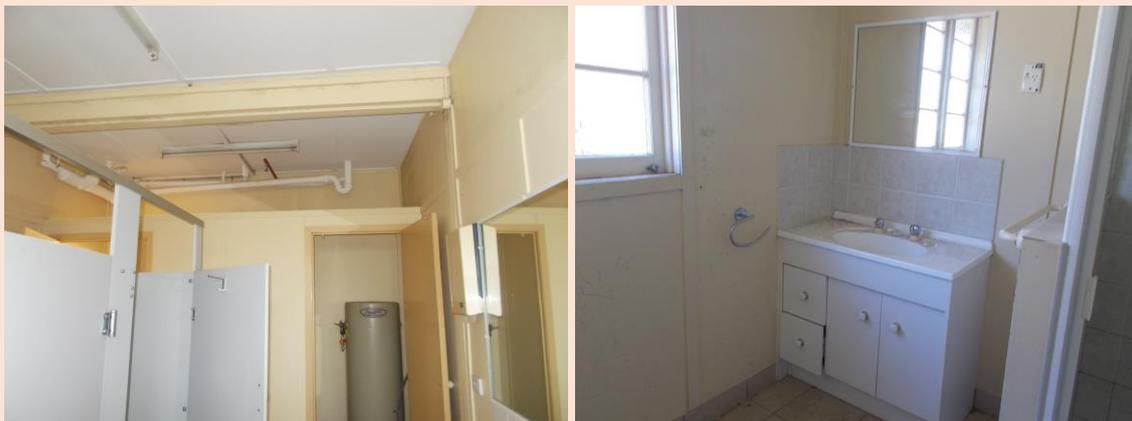
**Image 26: Examples of the mix of asbestos cement sheeting, non asbestos cement sheet, wood and plaster panels in the Ablution Areas.**

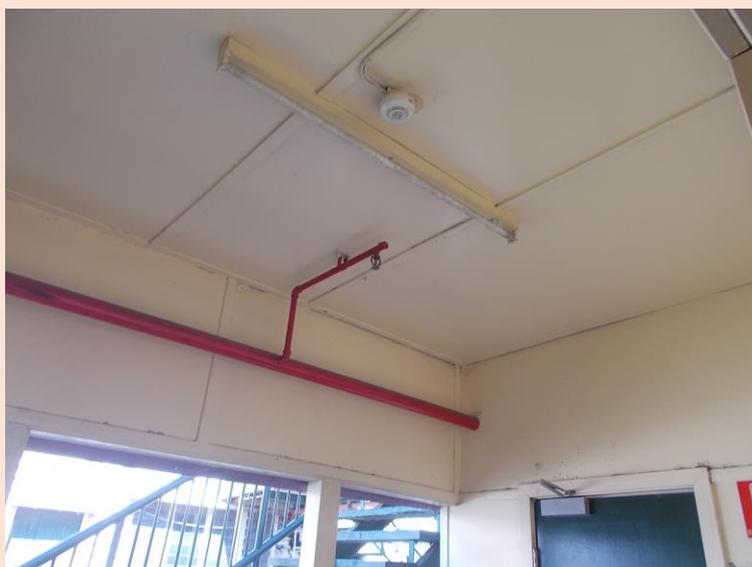
**Image 27: One of the areas of mixed material panels.**

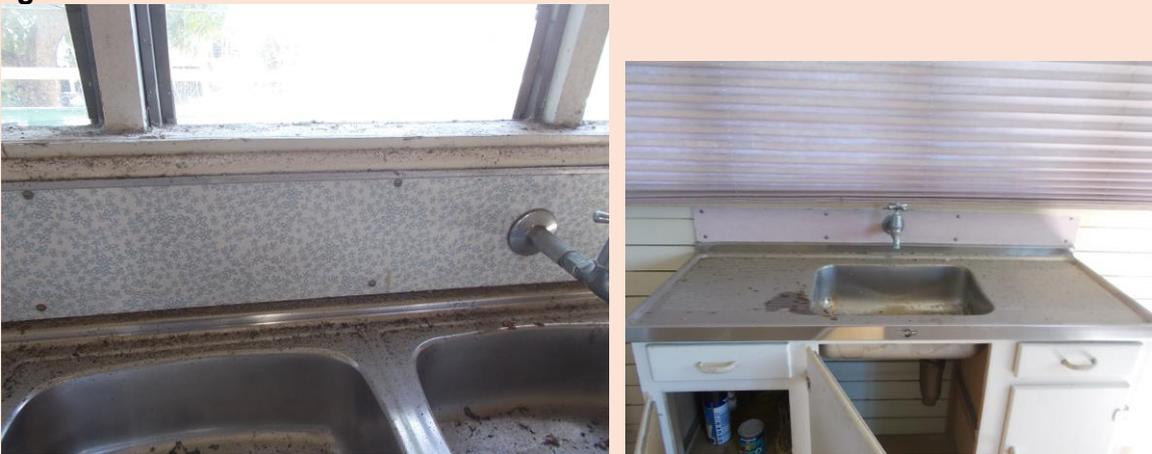
**Image 28: The sink backing panels are constructed of laminated asbestos cement sheeting.**

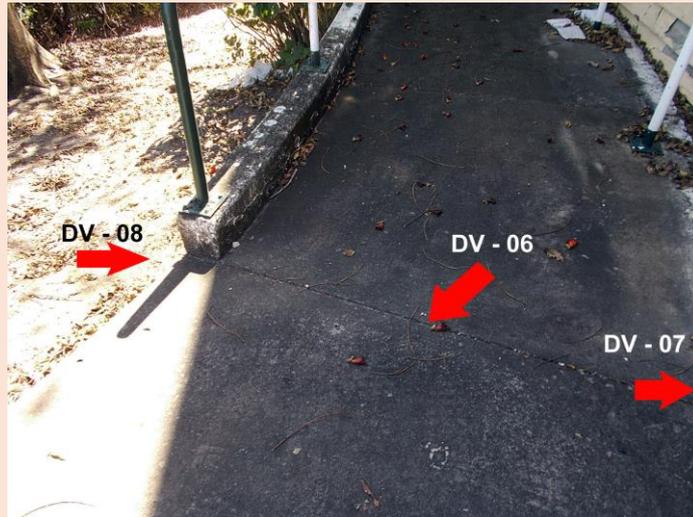
**Image 31: Main Entrance Footpath to the Main Hall Building: Location of samples**

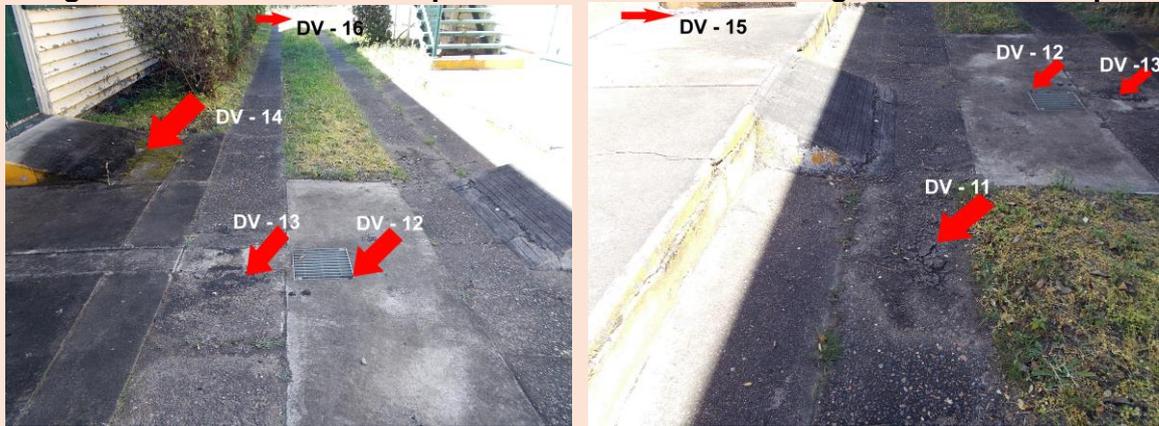
**Image 32: Locations of sample between the buildings. This is where a lot of asbestos contaminated run off has built up and is also the only vehicle access to the rear carpark**

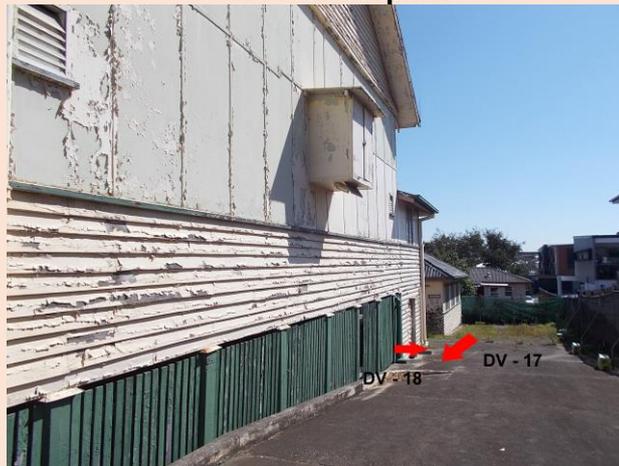
**Image 33: Back Carpark Behind Hall: Samples taken outside Laundry door.**

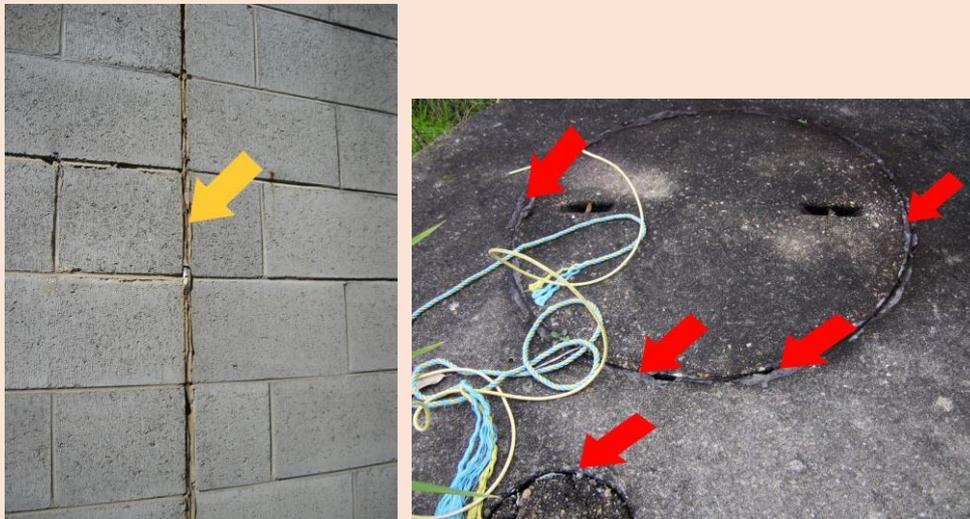
Image 34: Example of asbestos containing joint sealant. On the right Sealant on a septic tank inspection/pump hatch which contains asbestos

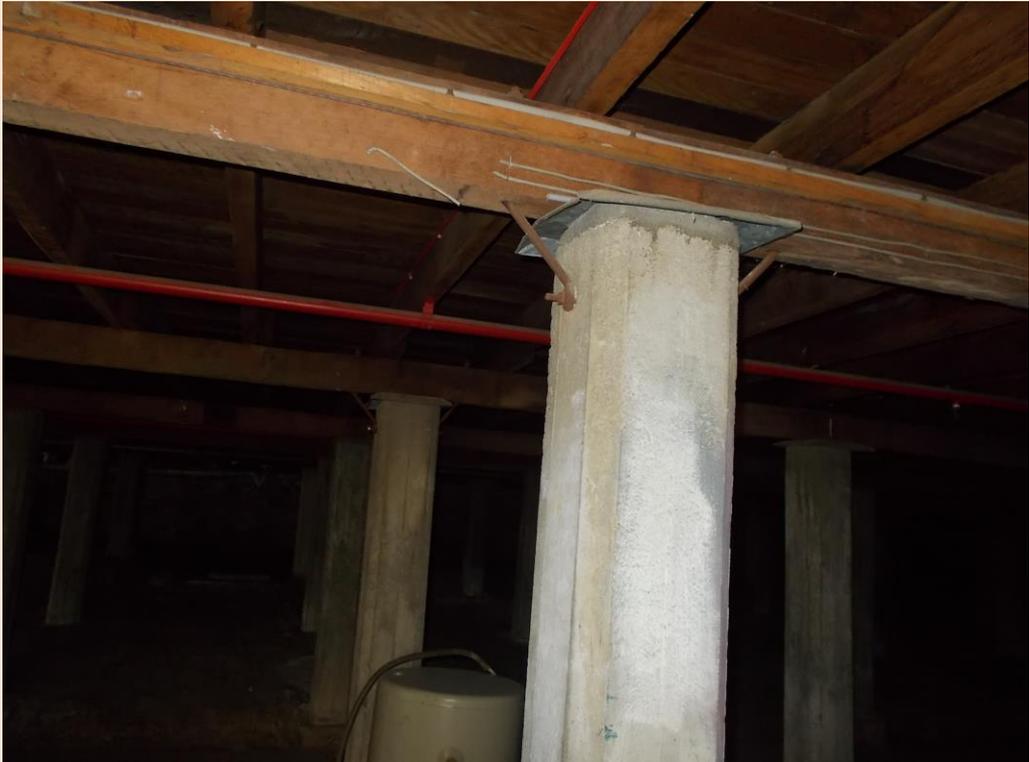
**Image 35: Stump Packing Beneath Building: Asbestos cement sheet pieces where commonly used for stump and floor support level packing.**

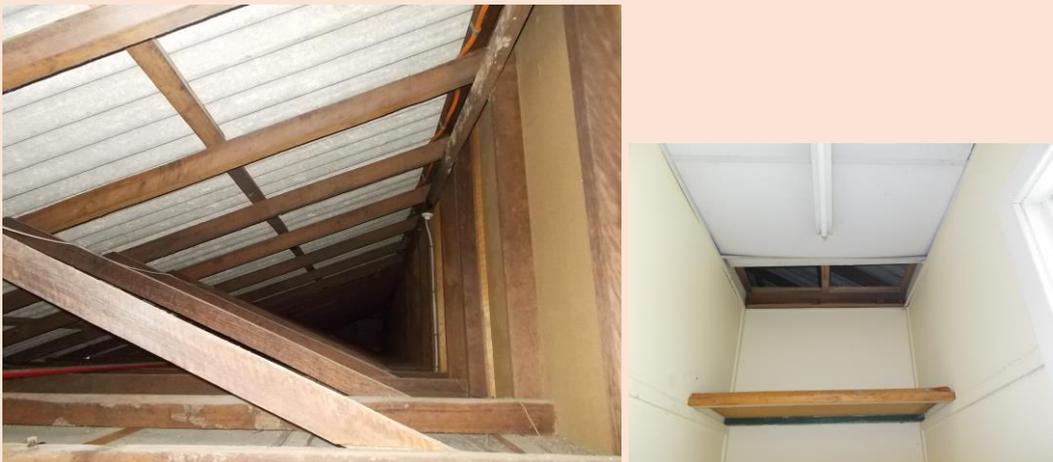
**Image 36: It is assumed that upper structural supports and beams and roof/ceiling spaces in general will be contaminated with asbestos that has gradually released over decades from the asbestos cement roof cladding. Shown is the roof cladding and open ceiling tile in the Accommodation Building**
