**Asbestos Management
Plan and Register for
114 Newdegate Street,
Greenslopes.**

Australian Red Cross Society

4 February 2015

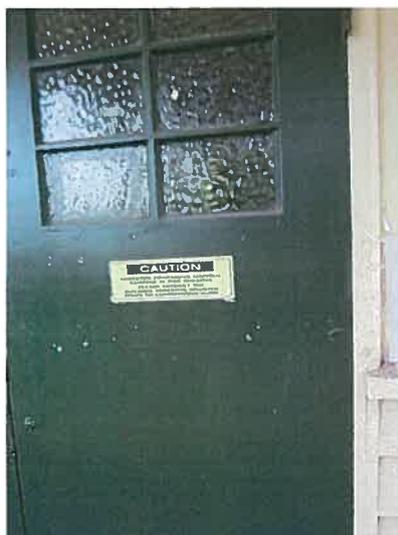
In these buildings signs were previously installed at the Front and Side Entrances only the Front Entrance one still remains.

Figure 1: Asbestos Register sign on the front door of the Main Hall Building.

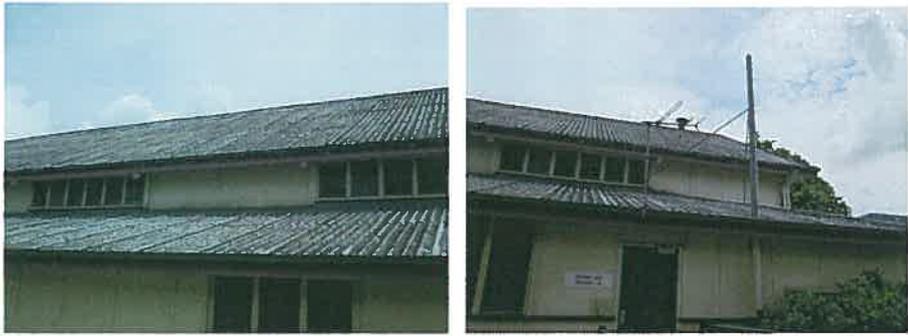
Site: 114 Newdegate Street, Greenslopes							
Competent Person: Brian Sketcher							
Date of Identification: 21st January 2015							
Location	Level	Room		Item		Product	
Internal	Ground	Roof		Roof cladding		Asbestos cement sheet	
Sealed	Condition	Friability		Access	M2	Sample No.	Image No.
No	Poor	Friable Upper Surfaces		A4	800	RX - 01	1
Comments	The roof cladding is corrugated asbestos cement sheeting this includes the edge and ridge capping. It was sealed in 2009 (refer to Appendix C) the sealant has deteriorated rapidly and recent hailstorms have pockmarked all the sheeting releasing additional asbestos from the mainly friable top surfaces.						
Recommendations	<i>Avoid further damage and abrasion. Remove and replace the roof if the building is still to be used or prior to renovation or demolition work.</i>						
Image

Image 1: The asbestos cement roof cladding showing very little sign of the sealant and is covered with tiny white damage marks from recent hailstorms.

The roof cladding had been painted slowing the deterioration and extending the life of the material. However it was applied unevenly and since its application in 2009 it has deteriorated to its previous condition and recent hailstorms have left hundreds of indentations in the now friable surface layer of the cladding releasing asbestos. Therefore replacement of the roof will be necessary and asbestos precautions still need to be applied when carrying out work at roof height on the building.

- 1) **The planned continued usage of these two buildings will need to be examined in order to determine if the buildings are worth retaining in their current form due to the amount of asbestos cement sheet used throughout them. The roofing was sealed (Refer to Appendix I) in 2009 but this was a stop gap measure adding only a few years to the roof cladding life, it is in an advanced state of deterioration due to break down of this coating and recent hailstorms and should be removed and replaced.**

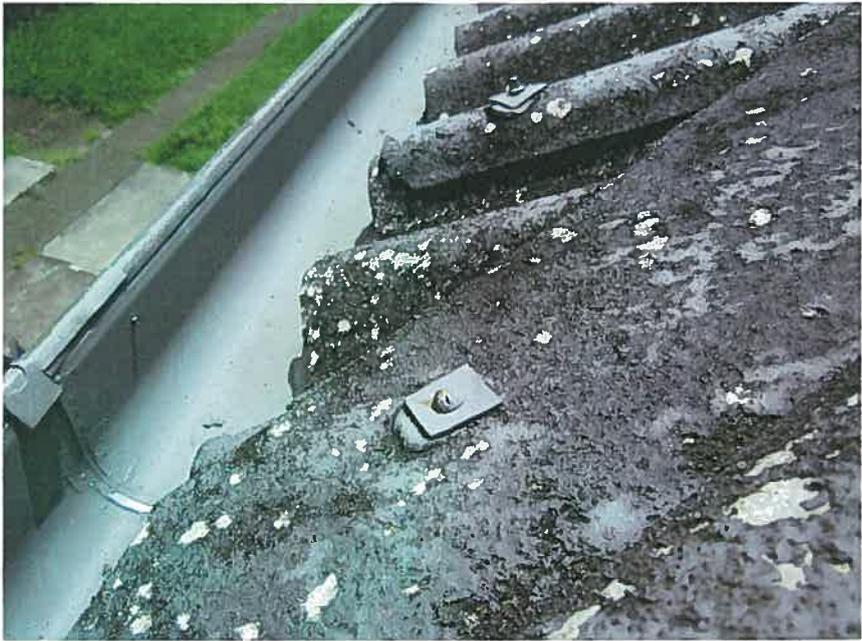
Site: 114 Newdegate Street, Greenslopes.						
Competent Person: Brian Sketcher						
Date of Identification: 21st January 2015						
Location	Level	Room	Item		Product	
External/ Internal	Roof	Nailheads	Nail sealant		Sealant	
Sealed	Condition	Friability	Access	M2	Sample No.	Image No.
Yes	Good	Non	A4	<5	Not sampled	2
Comments	The black sealant (painted grey) used to waterproof around the roofing nails contains asbestos.					
Recommendations	Avoid damage and abrasion. Remove if dismantling, structural alterations or demolition is to be carried out in this area. Reassess at least every five years or prior to renovation or demolition work. Label appropriately as per State Government Guidelines and the Code of Practice.					
Image

<p>Image 2: Roof sealant used at nail points to seal around the hole is an asbestos based sealant. Again note the hail damage to the surrounding sheeting.</p>

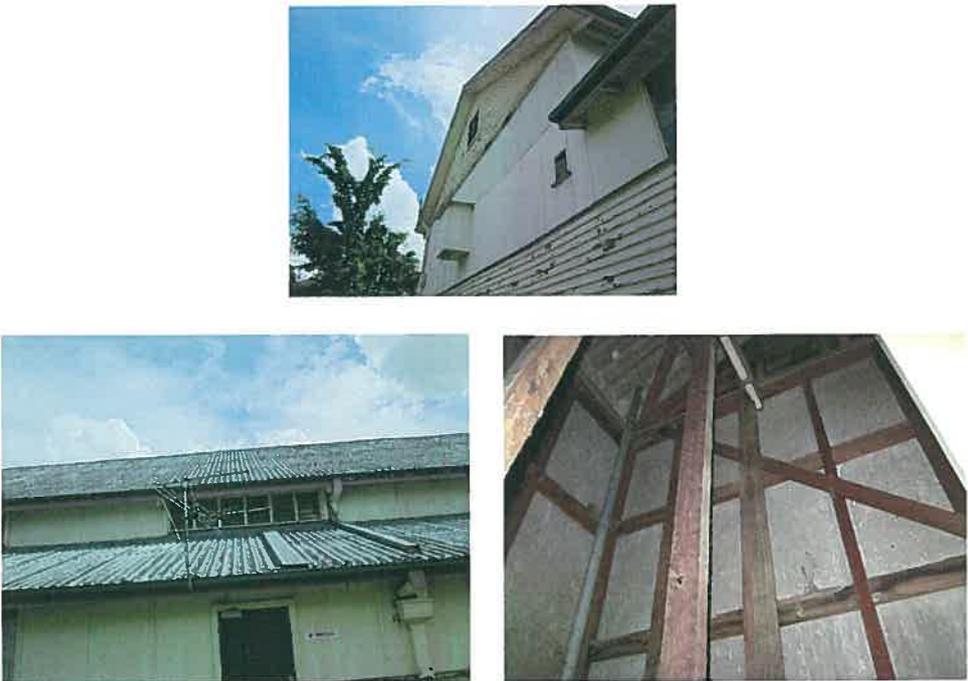
Site: 114 Newdegate Street, Greenslopes						
Competent Person: Brian Sketcher						
Date of Identification: 21st January 2015						
Location	Level	Room	Item		Product	
External	Ground	Perimeter	Wall cladding		Asbestos cement sheet	
Sealed	Condition	Friability	Access	M2	Sample No.	Image No.
Yes	Good	Non	A3	400	RX - 03	3
Comments	The main walls to the outside of the building are clad in asbestos cement sheeting. This material is painted and in mainly good condition, however on some areas of the walls the paint is peeling and behind the stage in the Main Hall building the rear wall is accessible and unpainted.					
Recommendations	Avoid damage and abrasion. Repaint peeling areas and paint unpainted rear of stage area. Remove if dismantling, structural alterations or demolition is to be carried out in this area. Reassess at least every five years or prior to renovation or demolition work. Label appropriately as per State Government Guidelines and the Code of Practice.

<p>Image 3: Asbestos cement wall cladding around the perimeter of the building. The bottom right image shows inside behind the stage where the wall cladding is unpainted.</p>

- 2) **Unpainted and deteriorating paintwork areas in other parts of the buildings need to be addressed by painting or repainting.**
- 3) **A mix of asbestos cement and wooden building sheeting and materials have been used throughout the building some even mixed on the same wall or ceiling area. It is therefore important that for all works that the materials involved are checked for asbestos before work commences.**

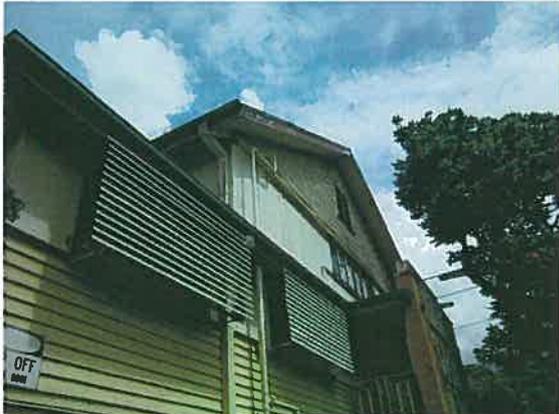
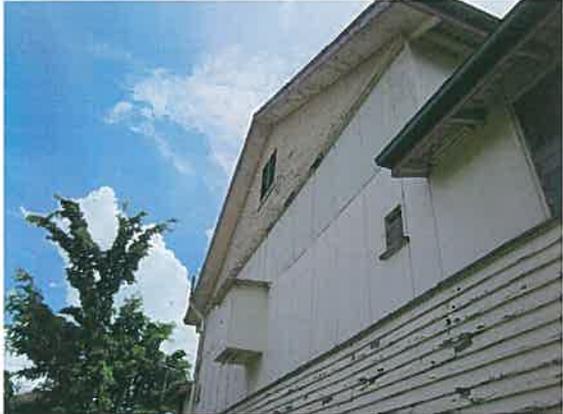
Site: 114 Newdegate Street, Greenslopes							
Competent Person: Brian Sketcher							
Date of Identification: 21st January 2015							
Location	Level	Room		Item		Product	
External	Ground	Eaves		Ceiling		Asbestos cement sheet	
Sealed	Condition		Friability	Access	M2	Sample No.	Image No.
Yes	Good		Non	A4	50	Similar to sample RX - 02	4
Comments	The external upper eaves (under the end pitched rooves) are lined in asbestos cement sheeting. This year (2015) it was noted that the paint has begun to flake in places so will require repainting.						
Recommendations	Avoid damage and abrasion. Remove if dismantling, structural alterations or demolition is to be carried out in this area. Reassess at least every five years or prior to renovation or demolition work. Label appropriately as per State Government Guidelines and the Code of Practice.						
Image

Image 4: The eaves of the building are lined with asbestos cement sheeting at the ends of the building.

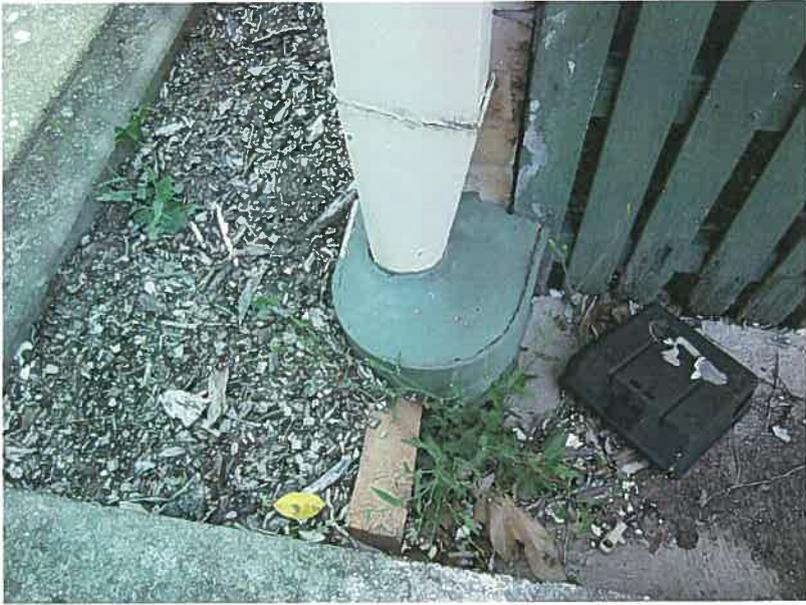
Site: 114 Newdegate Street, Greenslopes.							
Competent Person: Brian Sketcher							
Date of Identification: 21st January 2015							
Location	Level	Room		Item		Product	
External	Ground	Drain vents		Drain surrounds		Asbestos cement	
Sealed	Condition		Friability	Access	M2	Sample No.	Image No.
Yes	Good		Non	A2	2	Similar to sample RX - 01	5
Comments	External drain surrounds are asbestos cement.						
Recommendations	Avoid damage and abrasion. Remove if dismantling, structural alterations or demolition is to be carried out in this area. Reassess at least every five years or prior to renovation or demolition work. Label appropriately as per State Government Guidelines and the Code of Practice.						
Image

Image 5: External: Asbestos cement drain surround.

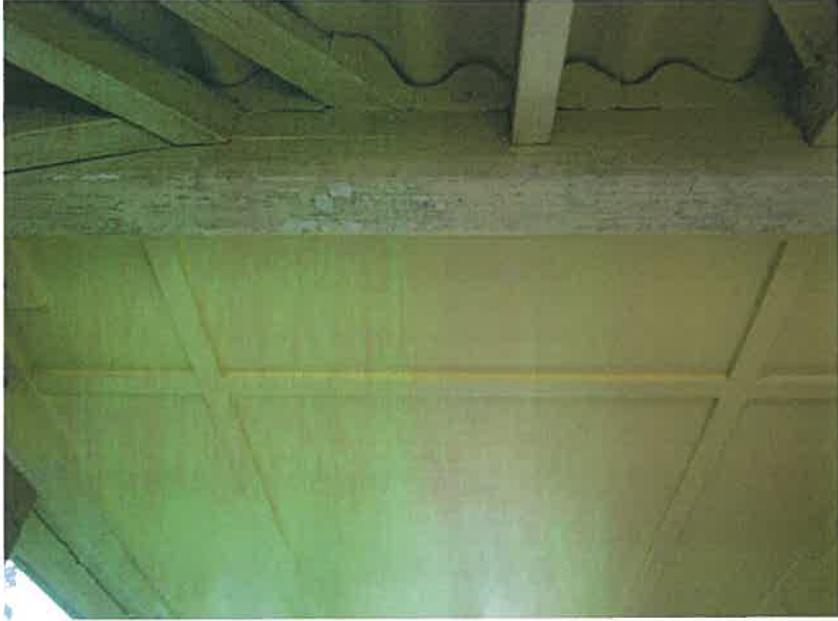
Site: 114 Newdegate Street, Greenslopes.						
Competent Person: Brian Sketcher						
Date of Identification: 21st January 2015						
Location	Level	Room	Item		Product	
External	Ground	Front Entrance Verandah	Ceiling lining		Asbestos cement sheet	
Sealed	Condition	Friability	Access	M2	Sample No.	Image No.
Yes	Good	Non	A3	12	RX - 02	6
Comments	Front verandah entrance ceiling is lined in asbestos cement sheet.					
Recommendations	Avoid damage and abrasion. Remove if dismantling, structural alterations or demolition is to be carried out in this area. Reassess at least every five years or prior to renovation or demolition work. Label appropriately as per State Government Guidelines and the Code of Practice.					
Image

Image 6: Front Verandah: Asbestos cement sheet ceiling lining.

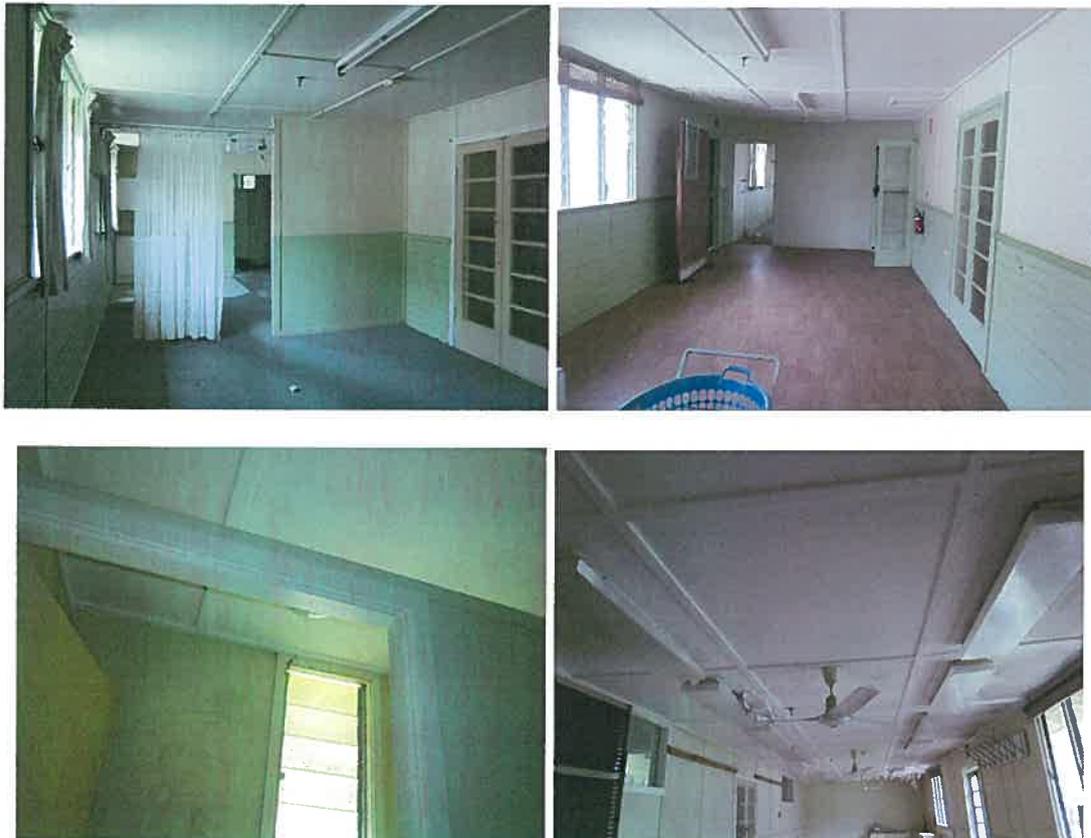
Site: 114 Newdegate Street, Greenslopes.						
Competent Person: Brian Sketcher						
Date of Identification: 21st January 2015						
Location	Level	Room	Item		Product	
External	Ground	All Side Rooms off the Main Hall	Ceiling lining		Asbestos cement sheet	
Sealed	Condition	Friability	Access	M2	Sample No.	Image No.
Yes	Good	Non	A3	200+	Similar to sample RX - 02	7
Comments	The ceilings in the Main Hall Building to all the lower ceiling areas including beneath the Projector Room and the two Separate Units are lined in asbestos cement sheeting.					
Recommendations	Avoid damage and abrasion. Remove if dismantling, structural alterations or demolition is to be carried out in this area. Reassess at least every five years or prior to renovation or demolition work. Label appropriately as per State Government Guidelines and the Code of Practice.

Image 7: Ceilings linings to all the lower side rooms are lined in asbestos cement sheet ceiling lining.

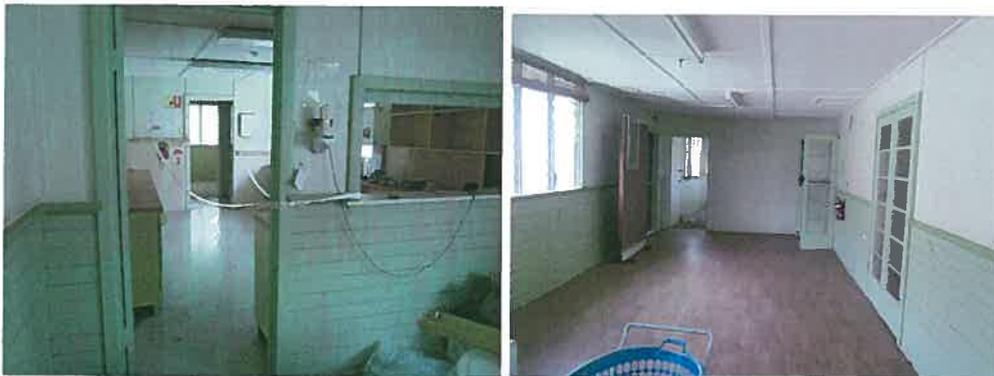
Site: 114 Newdegate Street, Greenslopes.							
Competent Person: Brian Sketcher							
Date of Identification: 21st January 2015							
Location	Level	Room	Item		Product		
Internal	Ground	All Side Rooms off the Main Hall	Wall linings		Asbestos cement sheet		
Sealed	Condition		Friability	Access	M2	Sample No.	Image No.
Yes	Good		Non	A2	200+	Similar to sample RX - 03	8 & 9
Comments	The walls in the Main Hall Building to all the lower ceiling areas including the two Units are lined in asbestos cement sheeting with some wooden and plaster panels as well.						
Recommendations	Avoid damage and abrasion. Remove if dismantling, structural alterations or demolition is to be carried out in this area. Reassess at least every five years or prior to renovation or demolition work. Label appropriately as per State Government Guidelines and the Code of Practice.

Image 8: Side rooms showing the mix of asbestos cement sheet and wood panelling used for the walls. The asbestos cement sheet probably goes down behind some of the wooden panels as well.

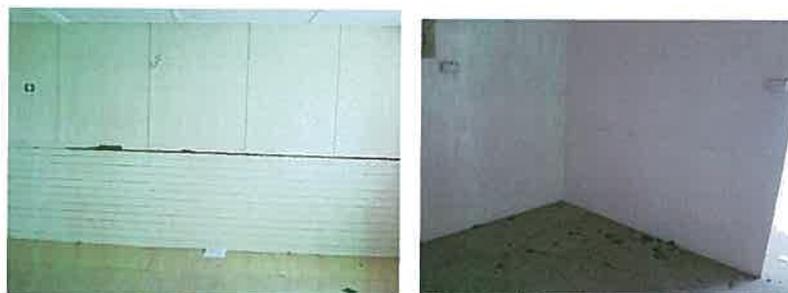
Image 9: Lower walls throughout a mix of mainly asbestos cement and wood panels.

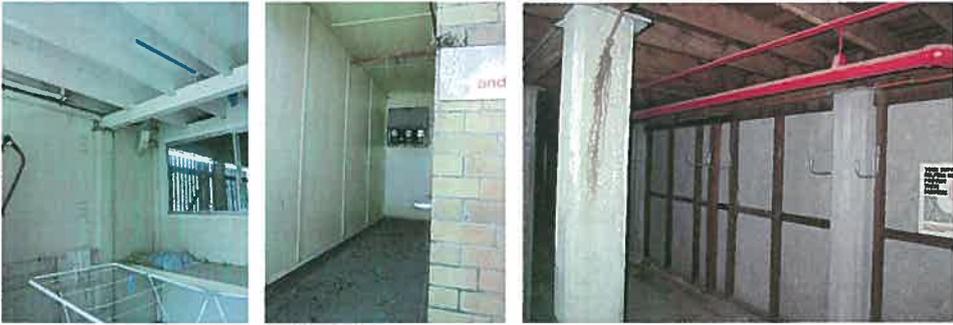
Site: 114 Newdegate Street, Greenslopes.						
Competent Person: Brian Sketcher						
Date of Identification: 21st January 2015						
Location	Level	Room	Item		Product	
Internal	Lower Ground	Former Workshops, Storerooms, Cab Toilet Entry, Laundry & Mattress Store	Wall linings		Asbestos cement sheet	
Sealed	Condition	Friability	Access	M2	Sample No.	Image No.
Yes	Good	Non	A2	100+	RX - 07	10 & 11
Comments	The walls in the downstairs areas including the main dividing wall, former Laundry, Mattress Store, Workshop, Storeroom and entrance to the former Cab Toilets are lined in asbestos cement sheeting. These areas are all now vacant. There are also a number of walls lined in wooden panelling and some single asbestos cement infill panels					
Recommendations	Avoid damage and abrasion. Remove if dismantling, structural alterations or demolition is to be carried out in this area. Reassess at least every five years or prior to renovation or demolition work. Label appropriately as per State Government Guidelines and the Code of Practice.

<p>Image 10: Downstairs rooms showing the mix of asbestos cement sheet and wood panelling used for the walls.</p>

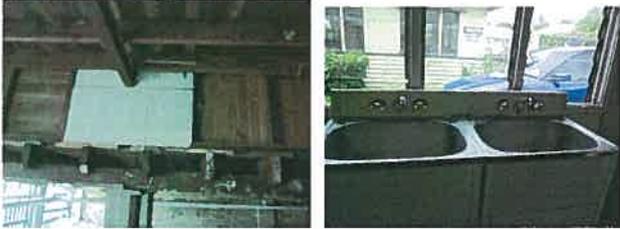
<p>Image 11: Examples of the single panels of asbestos cement sheeting.</p>

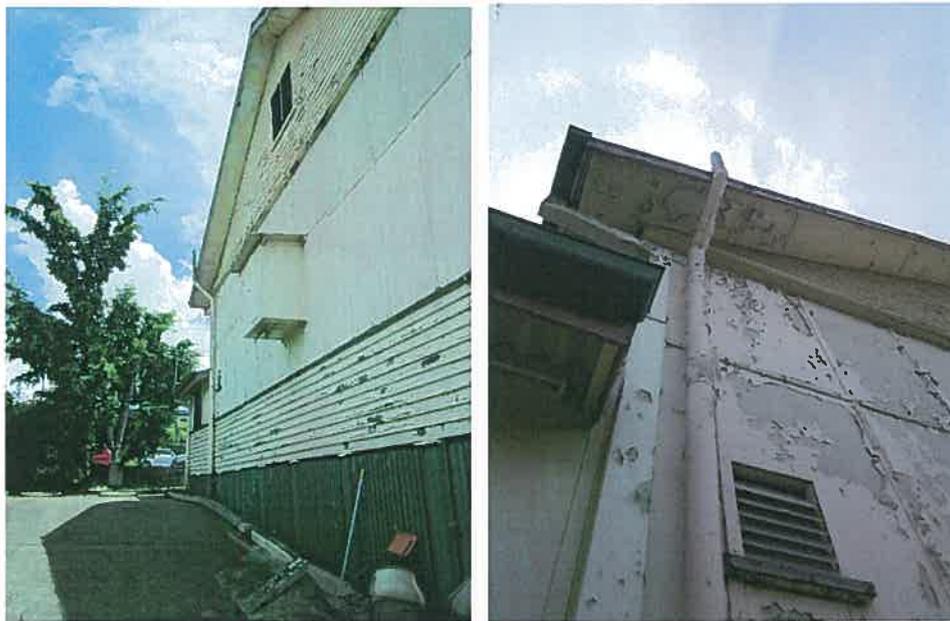
Site: 114 Newdegate Street, Greenslopes						
Competent Person: Brian Sketcher						
Date of Identification: 21st January 2015						
Location	Level	Room	Item		Product	
External	Ground	Outside Rear of Stage/Unit	Sewer vent pipe		Asbestos cement pipe	
Sealed	Condition	Friability	Access	M2	Sample No.	Image No.
Yes	Good	Non	A3	100mm X6m	Similar to sample RX - 01	12
Comments	The sewerage vent pipe extending up from the ground at the rear of the Main Hall Building has an asbestos cement pipe upper section.					
Recommendations	Avoid damage and abrasion. Remove if dismantling, structural alterations or demolition is to be carried out in this area. Reassess at least every five years or prior to renovation or demolition work. Label appropriately as per State Government Guidelines and the Code of Practice.

Image 12: Top section of the sewer vent pipe is asbestos cement pipe.

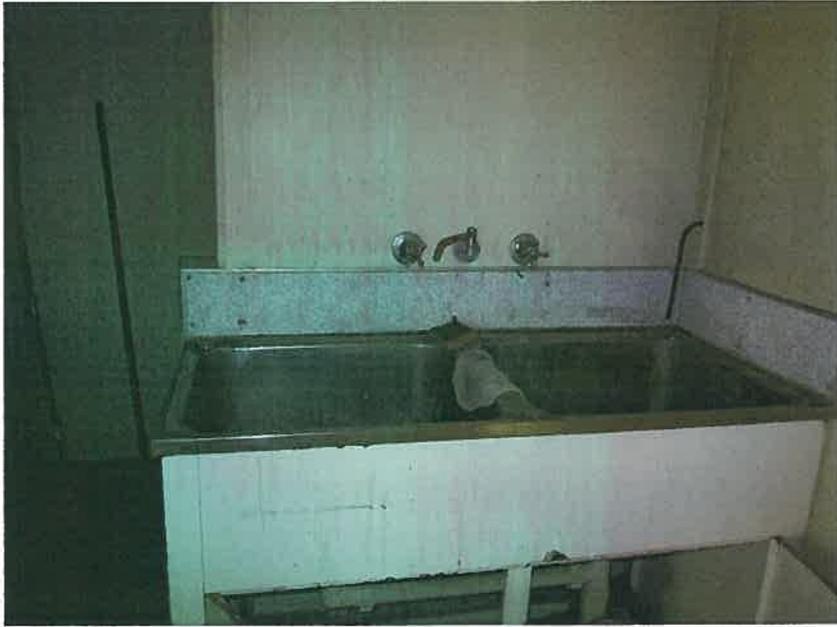
Site: 114 Newdegate Street, Greenslopes						
Competent Person: Brian Sketcher						
Date of Identification: 21st January 2015						
Location	Level	Room	Item		Product	
Internal	Lower Ground	Former Workshop	Laminated panels		Asbestos cement sheet	
Sealed	Condition	Friability	Access	M2	Sample No.	Image No.
Yes	Good	Non	A2	2	RX - 08	13
Comments	The sink backing panels are constructed of laminated asbestos cement sheeting.					
Recommendations	Avoid damage and abrasion. Remove if dismantling, structural alterations or demolition is to be carried out in this area. Reassess at least every five years or prior to renovation or demolition work. Label appropriately as per State Government Guidelines and the Code of Practice.					
Image

Image 13: Downstairs: Laminated asbestos cement sheet splash panels to the sink.

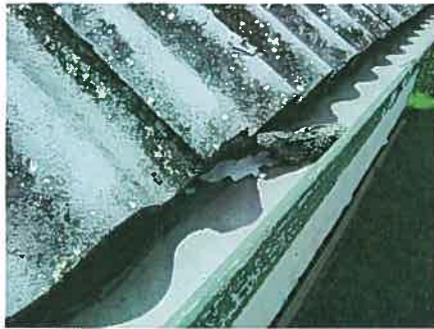
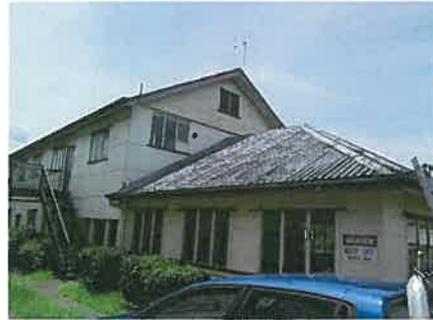
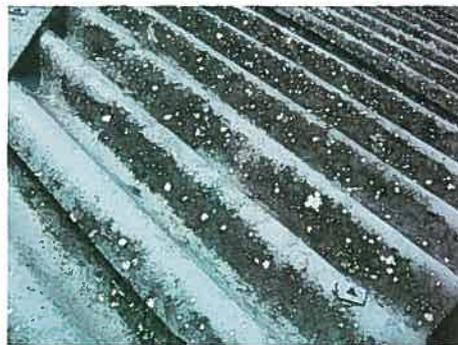
Site: 114 Newdegate Street, Greenslopes							
Competent Person: Brian Sketcher							
Date of Identification: 21 st January 2015							
Location	Level	Room	Item		Product		
Internal	Ground	Roof	Roof cladding		Asbestos cement sheet		
Sealed	Condition	Friability		Access	M2	Sample No.	Image No.
No	Poor	Friable	Upper Surfaces	A4	400	RX - 01	14
Comments	The roof cladding is corrugated asbestos cement sheeting this includes the edge and ridge capping. It was sealed in 2009 (refer to Appendix C) the sealant has deteriorated rapidly and recent hailstorms have pockmarked all the sheeting releasing additional asbestos from the mainly friable top surfaces.						
Recommendations	<i>Avoid further damage and abrasion. Remove and replace the roof if the building is still to be used or prior to renovation or demolition work.</i>

Image 14: The asbestos cement roof cladding still showing signs of the sealant and covered with tiny white damage marks from recent hailstorms.

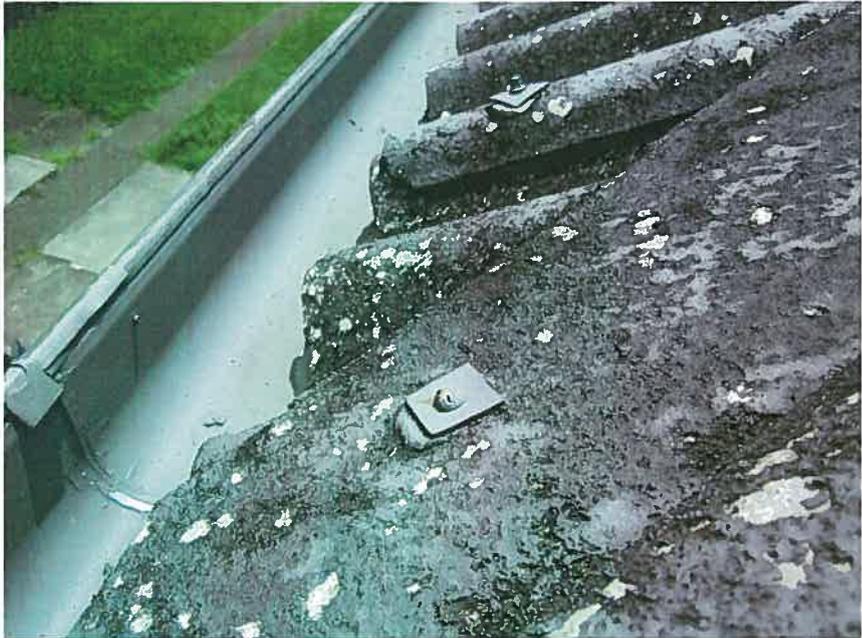
Site: 114 Newdegate Street, Greenslopes.						
Competent Person: Brian Sketcher						
Date of Identification: 21st January 2015						
Location	Level	Room	Item		Product	
External/ Internal	Roof	Nailheads	Nail sealant		Sealant	
Sealed	Condition	Friability	Access	M2	Sample No.	Image No.
Yes	Good	Non	A4	<5	Not sampled	15
Comments	The black sealant (painted grey) used to waterproof around the roofing nails contains asbestos.					
Recommendations	Avoid damage and abrasion. Remove if dismantling, structural alterations or demolition is to be carried out in this area. Reassess at least every five years or prior to renovation or demolition work. Label appropriately as per State Government Guidelines and the Code of Practice.					
Image

<p>Image 15: Sealant used at nail points to seal around the hole is an asbestos based sealant.</p>

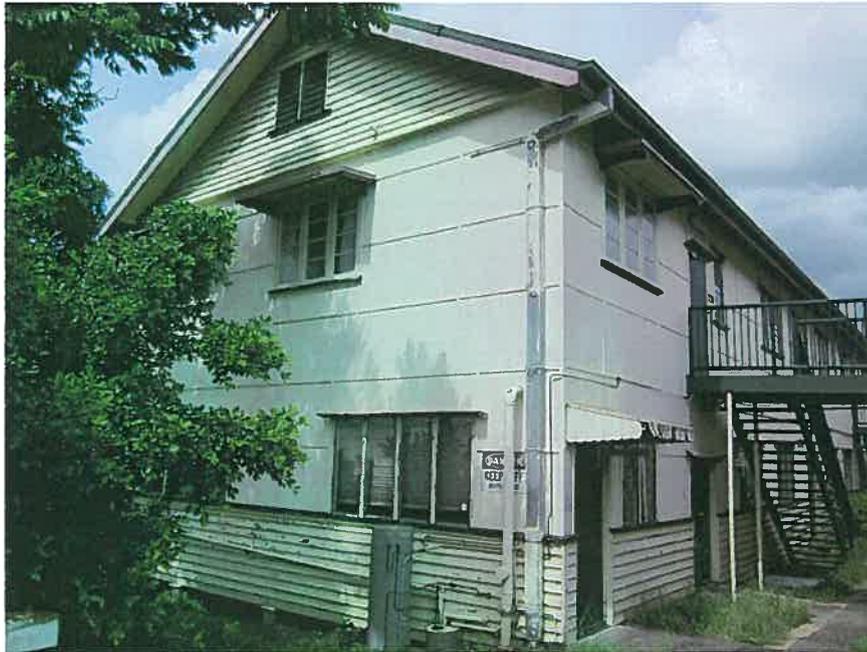
Site: 114 Newdegate Street, Greenslopes							
Competent Person: Brian Sketcher							
Date of Identification: 21st January 2015							
Location	Level	Room		Item		Product	
External	Ground	Perimeter		Wall cladding		Asbestos cement sheet	
Sealed	Condition		Friability	Access	M2	Sample No.	Image No.
Yes	Good		Non	A3	400	RX - 03	16
Comments	The main walls to the outside of the building are clad in asbestos cement sheeting. This material is painted and in good condition.						
Recommendations	Avoid damage and abrasion. Remove if dismantling, structural alterations or demolition is to be carried out in this area. Reassess at least every five years or prior to renovation or demolition work. Label appropriately as per State Government Guidelines and the Code of Practice.

Image 16: Wall cladding around the outside of the building is asbestos cement sheeting.

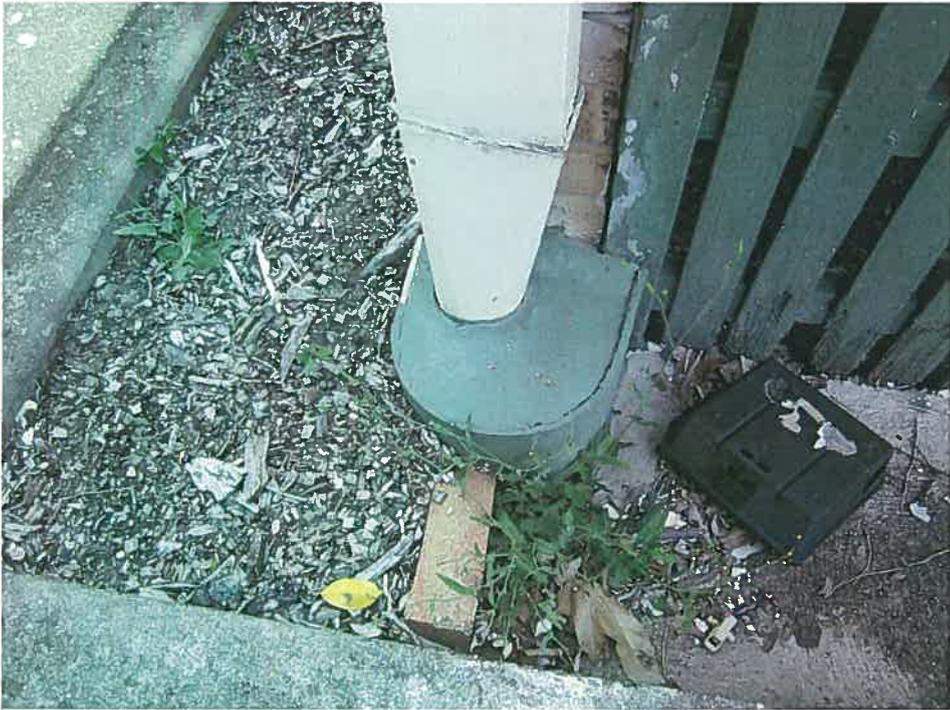
Site: 114 Newdegate Street, Greenslopes.							
Competent Person: Brian Sketcher							
Date of Identification: 21st January 2015							
Location	Level	Room		Item		Product	
External	Ground	Drain vents		Drain surrounds		Asbestos cement	
Sealed	Condition		Friability	Access	M2	Sample No.	Image No.
No	Good		Non	A2	2	Similar to sample RX - 01	17
Comments		External drain surrounds					
Recommendations		Avoid damage and abrasion. Paint or seal to limit further deterioration. Remove if dismantling, structural alterations or demolition is to be carried out in this area. Reassess at least every five years or prior to renovation or demolition work. Label appropriately as per State Government Guidelines and the Code of Practice.					
Image

Image 17: External: Asbestos cement drain surround.

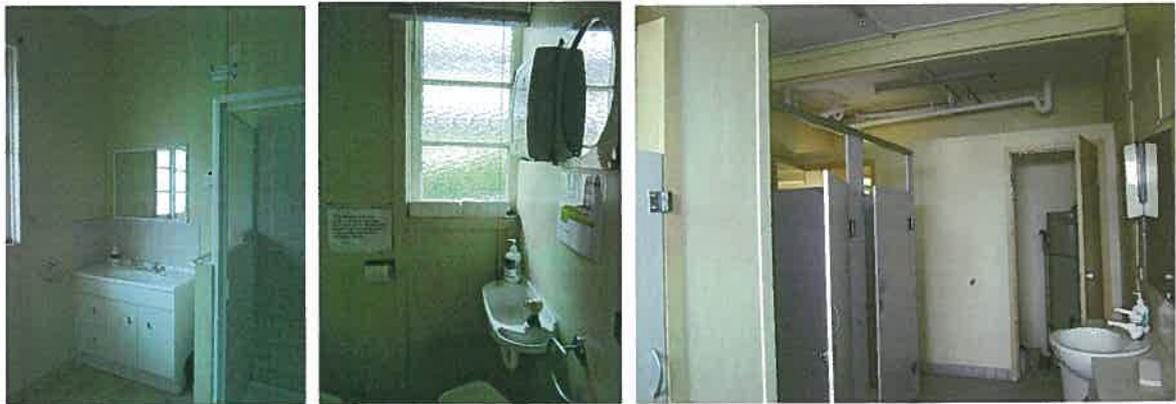
Site: 114 Newdegate Street, Greenslopes.						
Competent Person: Brian Sketcher						
Date of Identification: 21 st January 2015						
Location	Level	Room	Item		Product	
Internal	Ground & First	Ablutions Rooms	Ceiling & Wall Panels		Asbestos cement sheet	
Sealed	Condition	Friability	Access	M2	Sample No.	Image No.
Yes	Good	Non	A2	30	Similar to sample RX - 07	18
Comments	Some of the ceilings and walls in the Ablutions Areas for the Accommodation Rooms are lined in asbestos cement sheet. There are also wood and plaster panels used in this area. Without sampling each and every panel it is not possible to ascertain which are asbestos cement and which are non asbestos fibrous cement.					
Recommendations	Avoid damage and abrasion. Remove if dismantling, structural alterations or demolition is to be carried out in this area. Reassess at least every five years or prior to renovation or demolition work. Label appropriately as per State Government Guidelines and the Code of Practice.

<p>Image 18: Examples of the mix of asbestos cement sheeting, non asbestos cement sheet, wood and plaster panels in the Ablution Areas.</p>

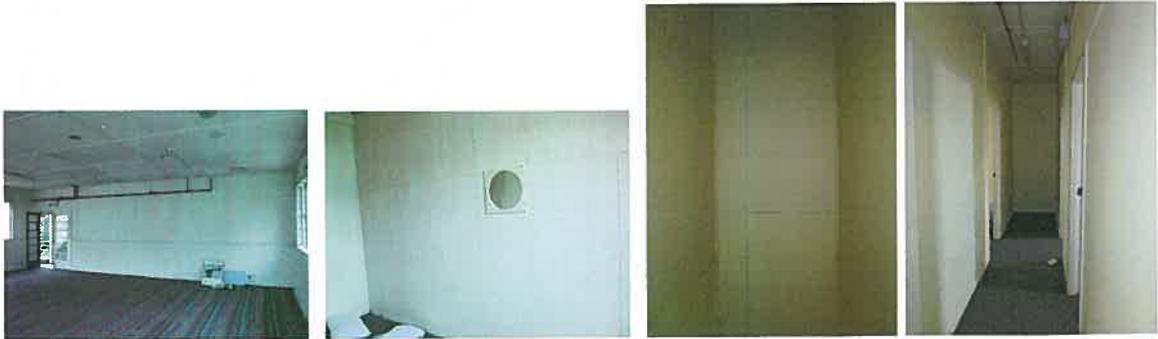
Site: 114 Newdegate Street, Greenslopes.						
Competent Person: Brian Sketcher						
Date of Identification: 21st January 2015						
Location	Level	Room	Item		Product	
Internal	Ground & First	Throughout	Ceiling & Wall panels		Asbestos cement sheet	
Sealed	Condition	Friability	Access	M2	Sample No.	Image No.
Yes	Good	Non	A2	24	Similar to sample RX - 07	19 & 20
Comments	Some of the wall and ceiling panels in this building are asbestos cement sheet however the bulk of it appears to be wood and plaster panels. Without sampling each and every panel it is not possible to ascertain which are asbestos cement and which are non asbestos fibrous cement. The rooms are all vacant so we have not assigned them designations					
Recommendations	Avoid damage and abrasion. Remove if dismantling, structural alterations or demolition is to be carried out in this area. Reassess at least every five years or prior to renovation or demolition work. Each panel will need to be checked in a systematic process to ascertain which are asbestos cement and all other types of panels. Label appropriately as per State Government Guidelines and the Code of Practice.

<p>Image 19: Examples of the mix of asbestos cement sheeting, wood and plaster panels in some of the rooms. From a WH & S standpoint it is preferred to assume all fibre cement sheeting contains asbestos.</p>

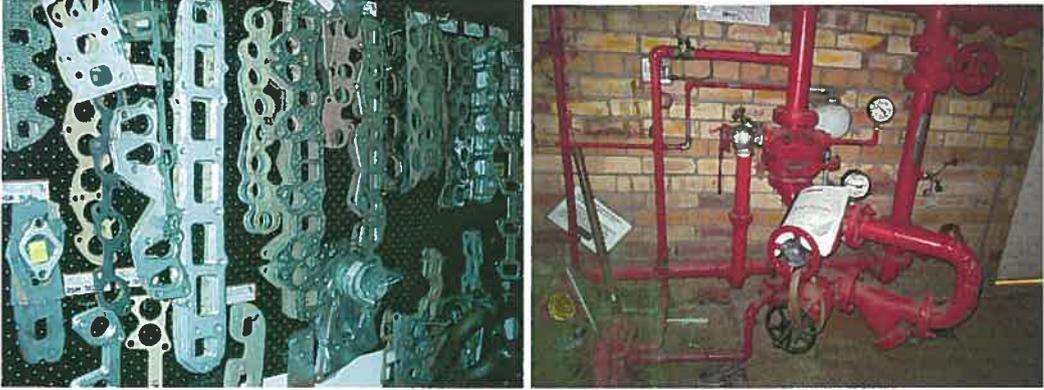
Site: 114 Newdegate Street, Greenslopes.						
Competent Person: Brian Sketcher						
Date of Identification: 21st January 2015						
Location	Level	Room	Item		Product	
Internal	Ground	Throughout	Minor machinery		Gaskets, seals and clutch linings	
Sealed	Condition	Friability	Access	M2	Sample No.	Image No.
Yes	Good	Non	A3	-	Not sampled	22
Comments	Gaskets & seals on machinery such as sprinkler systems may contain asbestos components if constructed prior to 2003.					
Recommendations	Avoid damage and abrasion. During maintenance replace with non asbestos alternative. Remove if dismantling, structural alterations or demolition is to be carried out in this area. Reassess at least every five years or prior to renovation or demolition work. Label appropriately as per State Government Guidelines and the Code of Practice.					
Image

<p>Image 22: Examples of asbestos containing gaskets and seals and onsite sprinkler system which may use such gaskets</p>

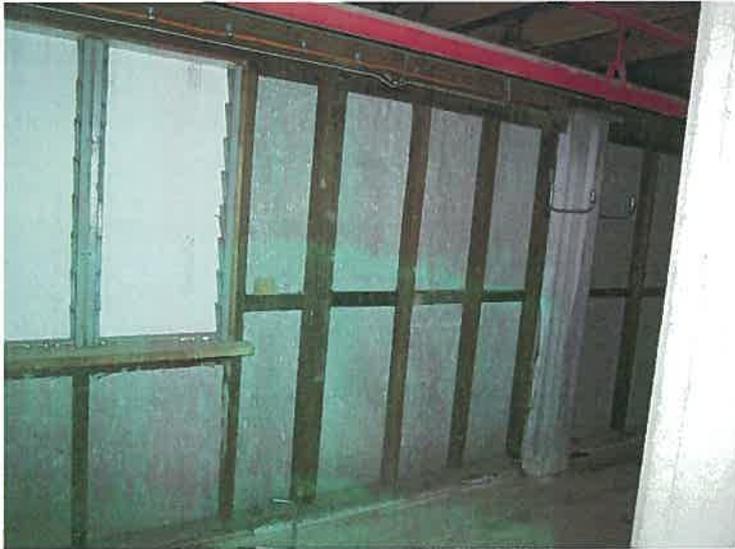
Site: 114 Newdegate Street, Greenslopes							
Competent Person: Brian Sketcher							
Date of Identification: 21st January 2015							
Location	Level	Room		Item		Product	
Internal	Ground	Top of stumps		Sheeting packing	level	Asbestos cement Sheet	
Sealed	Condition		Friability	Access	M2	Sample No.	Image No.
No	Medium		Non	A2	<0.5	Similar to sample RX - 02	23
Comments	Sheeting pieces assumed to be used as stump level packing beneath the buildings.						
Recommendations	Avoid damage and abrasion. Remove and cleanup prior to dismantling, structural alterations or demolition being carried out in this area. Reassess at least every five years or prior to renovation or demolition work. Label appropriately as per State Government Guidelines and the Code of Practice.						
Image

<p>Image 23: Stumps (including concrete ones- right) often had pieces of asbestos cement placed on top to assist with levelling.</p>

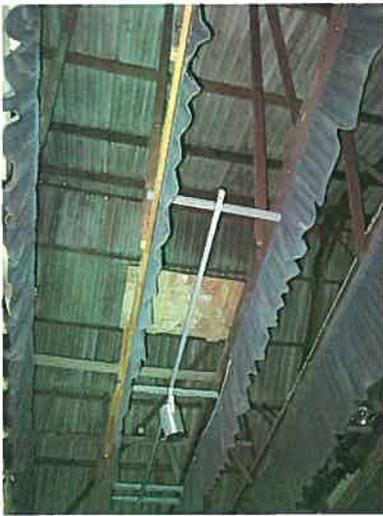
Site: 114 Newdegate Street, Greenslopes							
Competent Person: Brian Sketcher							
Date of Identification: 21st January 2015							
Location	Level	Room		Item		Product	
External	Ground	Roof		Roof cladding		Asbestos Cement sheet	
Sealed	Condition		Friability	Access	M2	Sample No.	Image No.
No	Medium		Friable	A4	-	Similar to sample RX - 01	24
Comments	The roof is clad in corrugated asbestos cement sheet along with asbestos debris in the gutter. As the underside of this cladding is unsealed it should be assumed that dust containing asbestos may be gradually depositing upon areas below. This has been found to be the case in many buildings with such rooves, particularly on the nearest flat horizontal surfaces to the roof cladding (i.e. beams, trusses or other structural supports including any suspended ceiling below						
Recommendations	<p>Avoid further damage and abrasion. Ensure appropriate PPE and procedures are in place when working beneath such roof cladding especially in confined ceiling or upper structural areas close to the roof cladding.</p> <p>Monitor condition and review at least annually. Label appropriately as per State Government Guidelines and the Code of Practice.</p>

<p>Image 24: The underside of the asbestos cement roof cladding. Asbestos contaminated dust slowly trickles from the sheeting as it deteriorates landing on the areas below. This was behind the stage.</p>
