**DEPARTMENT OF VETERAN AFFAIRS
PHASE 1 CONTAMINATED LAND
ASSESSMENT
114 NEWDEGATE STREET
GREENSLOPES QUEENSLAND**

Report Date: 24 September 2013
Project Ref: ENAURHOD06233AA

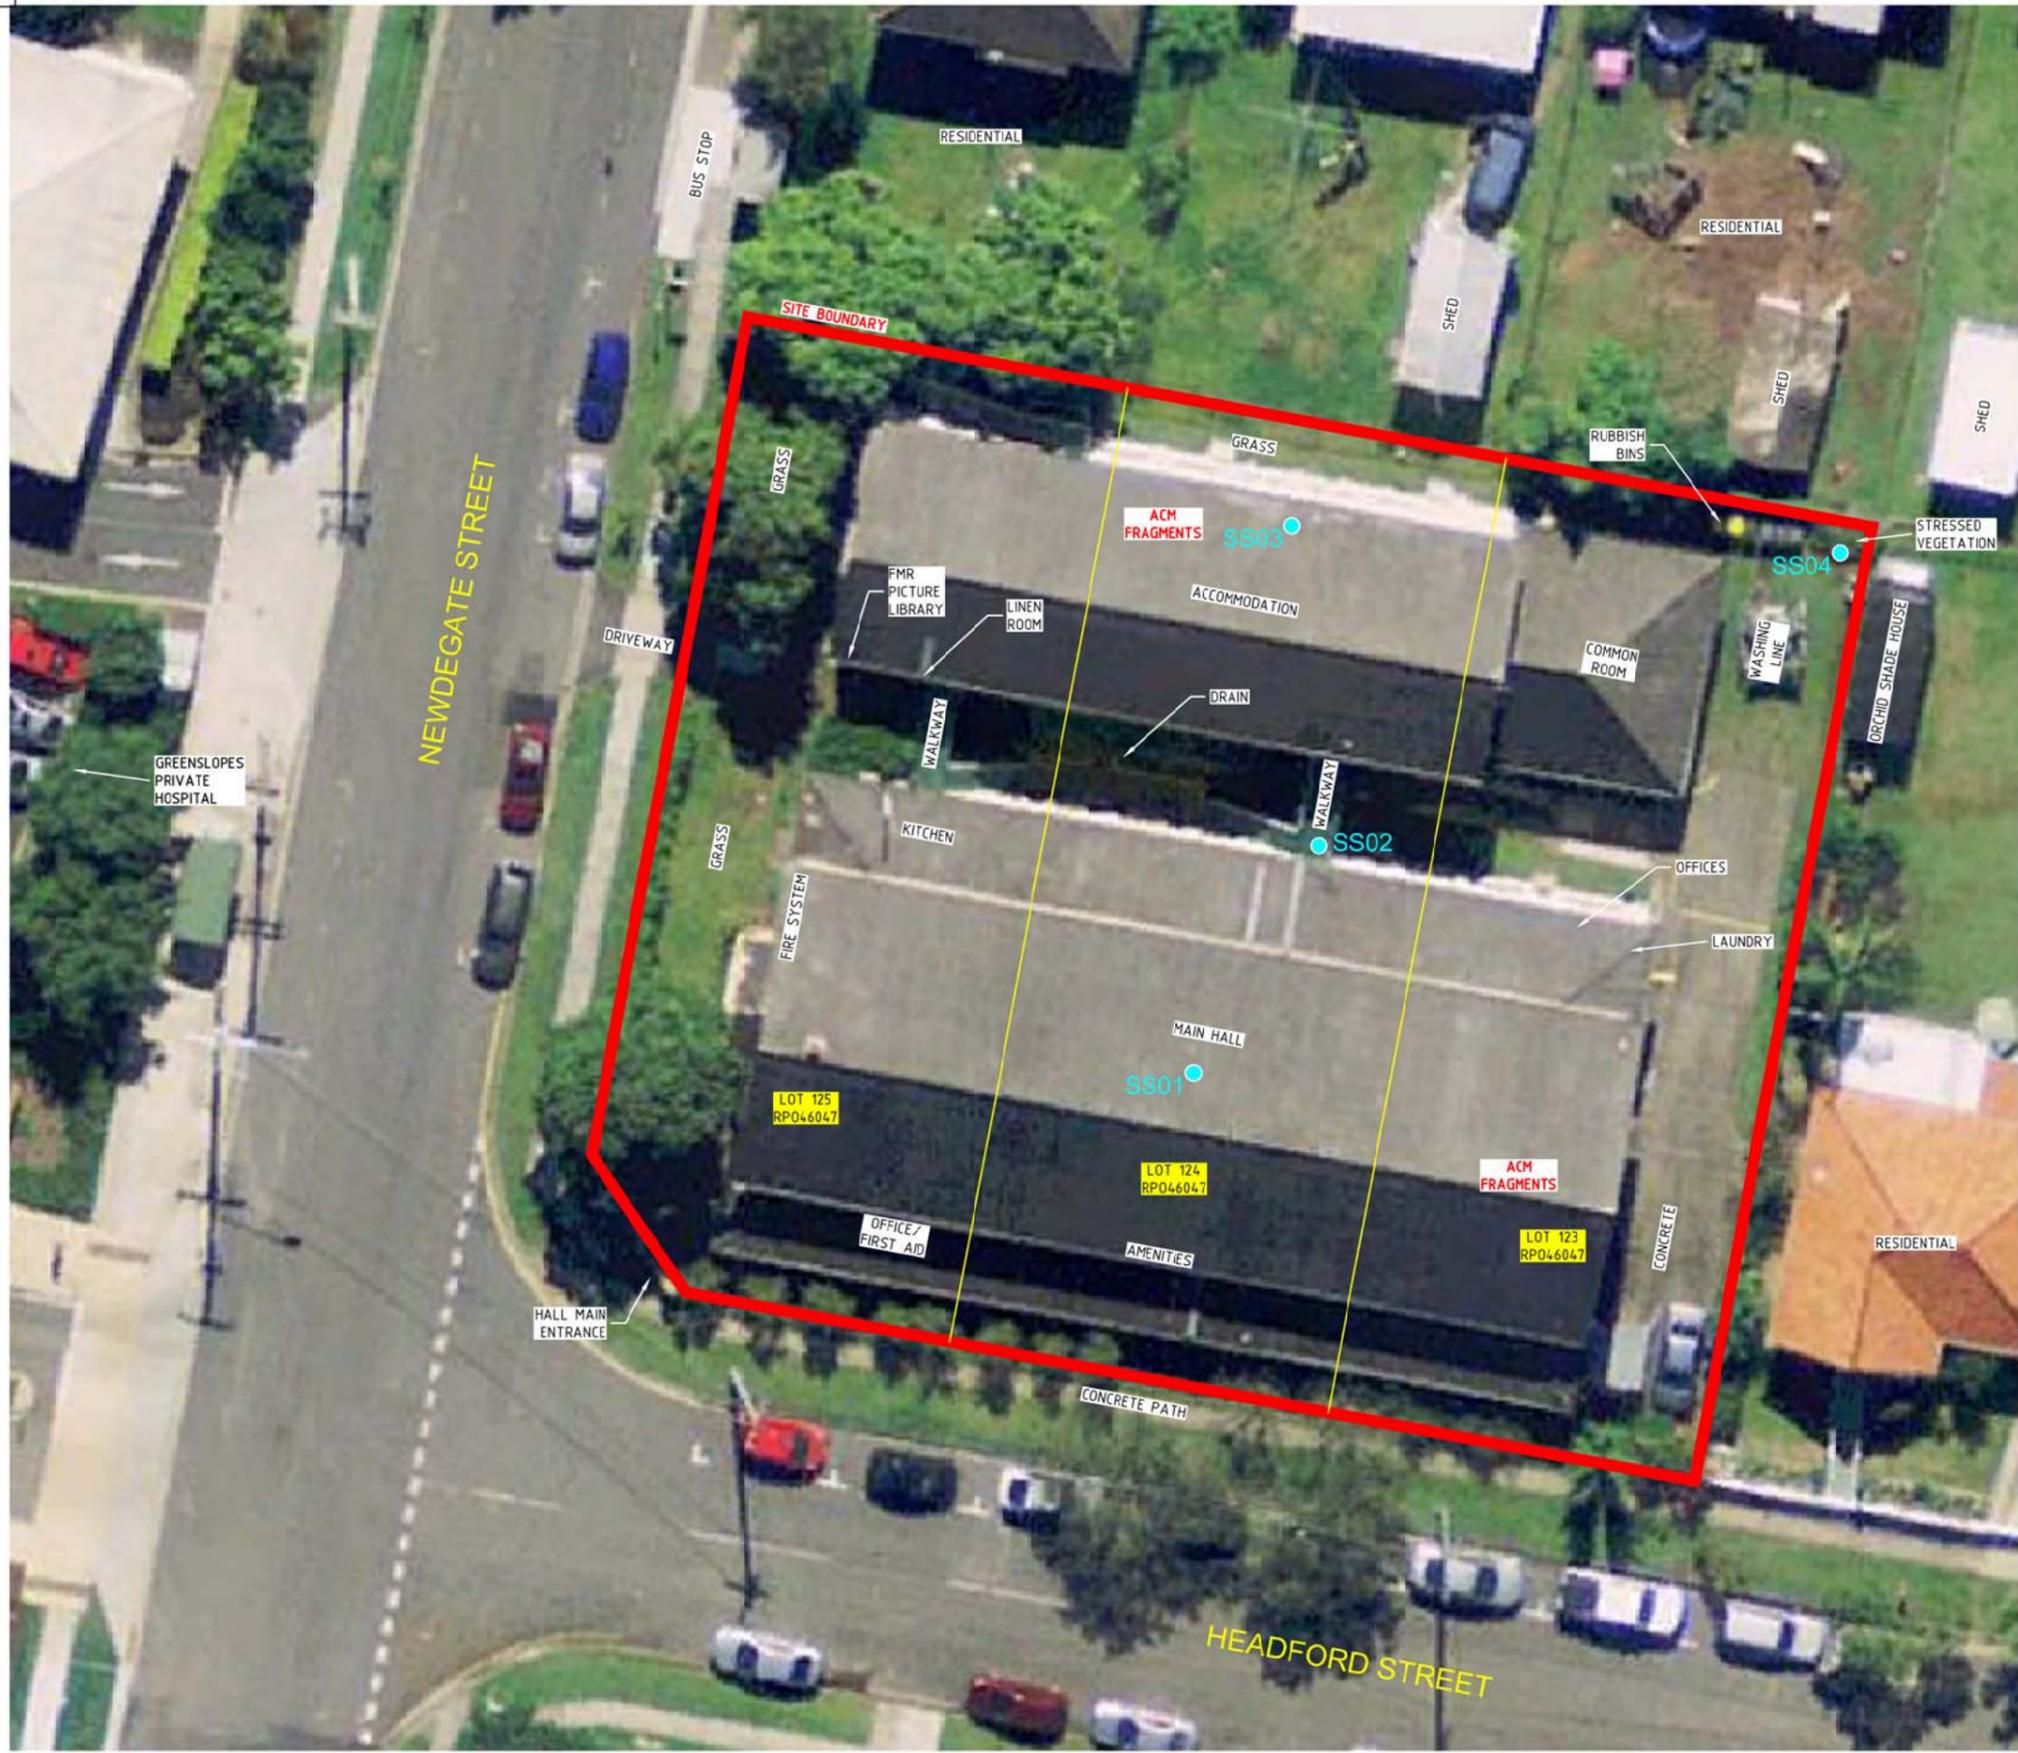
Drawn LZ	Date 31.07.13
Project - Drawing No. ENAUH006233AA-D01	Figure No. 1
	Rev. A

Sample No.	Activities/Infrastructure Targeted/Soil Type
SS01	Area of salt accumulation beneath the southern building. Targeting asbestos and potential pesticide use. Clayey SILT, brown, moist, 0-50mm.
SS02	Within an unsealed area immediately below peeling paint and adjacent to timber potentially treated with pesticides and fibro cement sheeting. Silty Sand, organic matter, brown, moist, 0-50mm.
SS03	Beneath the northern building targeting asbestos and potential pesticide use. Clayey sandy SILT, dry, brown, 0-50mm.
SS04	Wheelie bin storage area and area of compost pile and stressed vegetation. Targeting pesticides and other wastes. Sandy Clay, organic matter, low plasticity, moist, brown, 0-100mm.

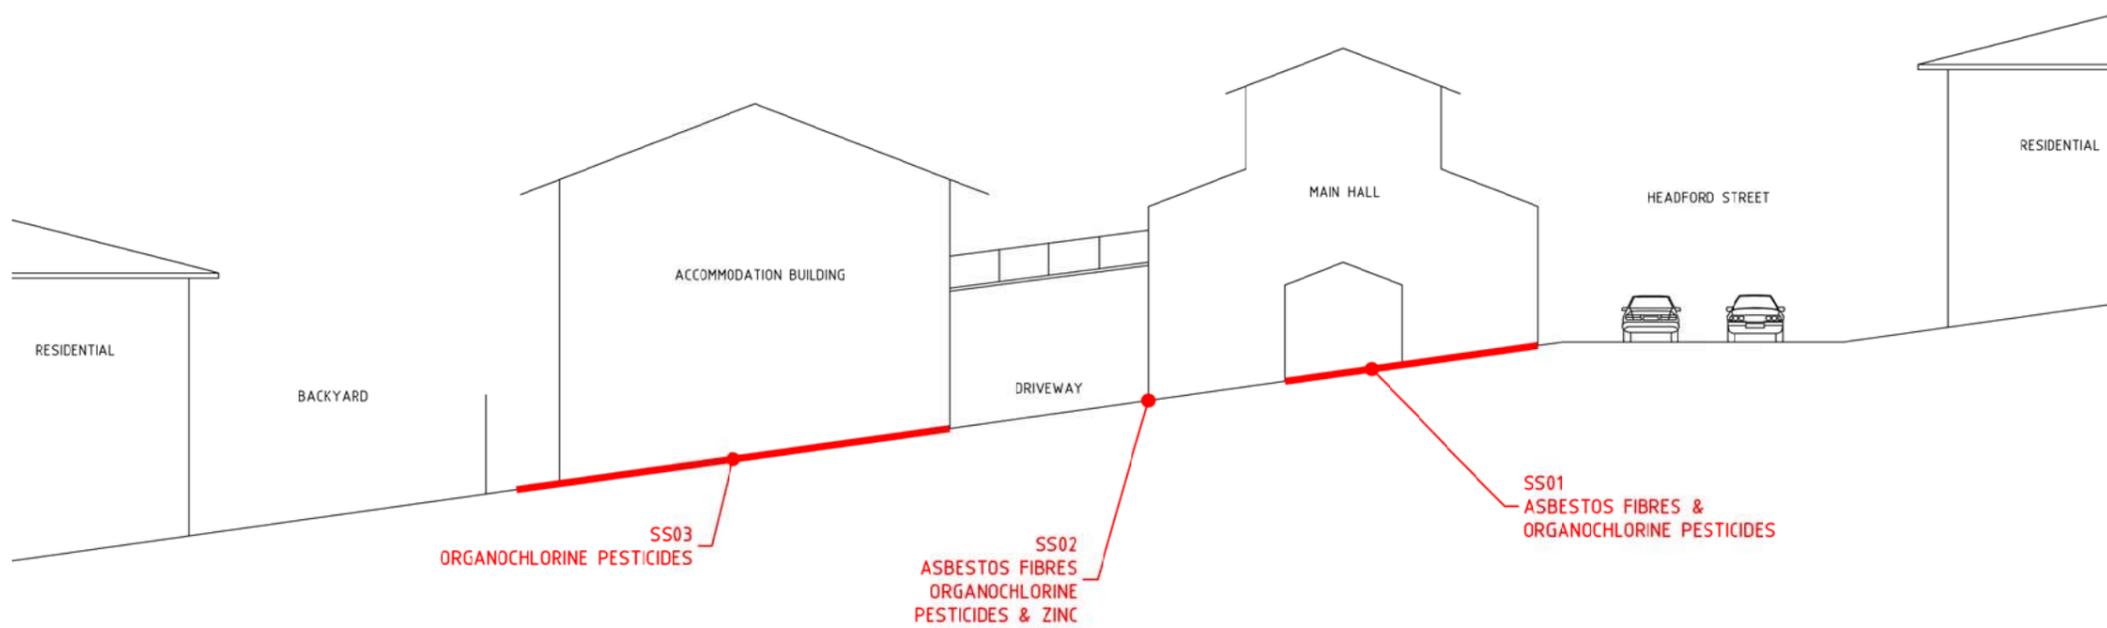
Drawn LZ	Date 31.07.13
Project - Drawing No. ENAUH006233AA-D01	Figure No. 2
	Rev. A

- Fragments of asbestos containing materials were observed beneath both site buildings and within the front vegetated area. The fragments of asbestos containing materials observed were generally in poor condition and lying on the soil surface.
- Paint on the buildings was in poor condition and peeling and has the potential to contain lead and other metals.
- Evidence of former termite infestations was present underneath the southern building. Pesticides may have been used to remove the termite infestation.
- There is potential for pesticide use in the north eastern corner of the site where stressed vegetation was present and a neighbouring property had an orchid shade house.

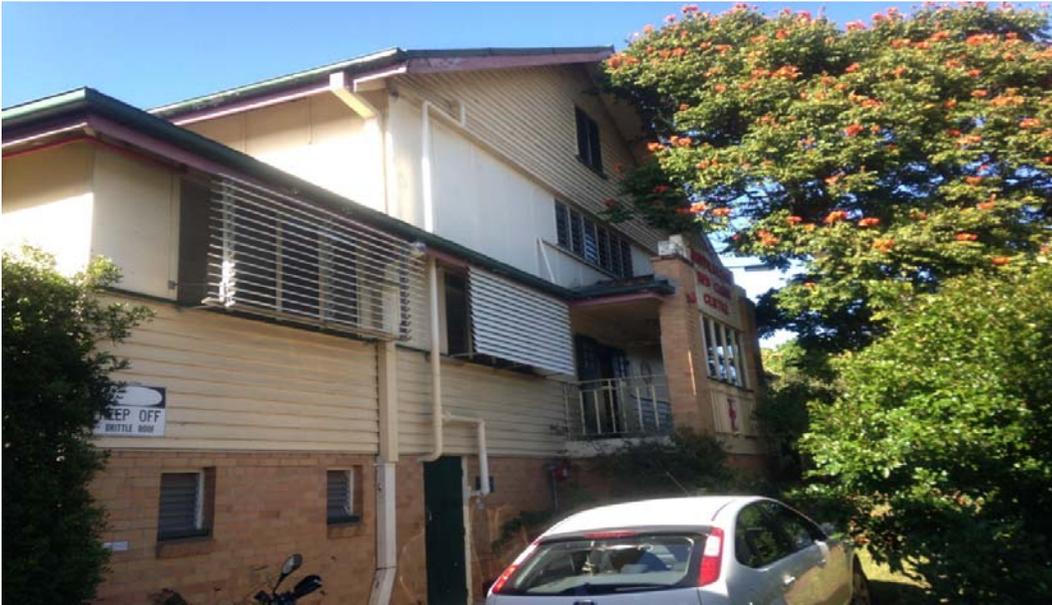
The southern building was predominantly used as a community hall and included a stage, cinema projection box, two care taker residences, kitchen, dining area, storage areas, amenities, offices, small property maintenance workshop and cleaners store room. The southern building was generally in poor condition with peeling paint, fibro cement sheeting and corrugated asbestos cement sheeting roofing.

Photograph 1 – Southern Building containing the main hall.

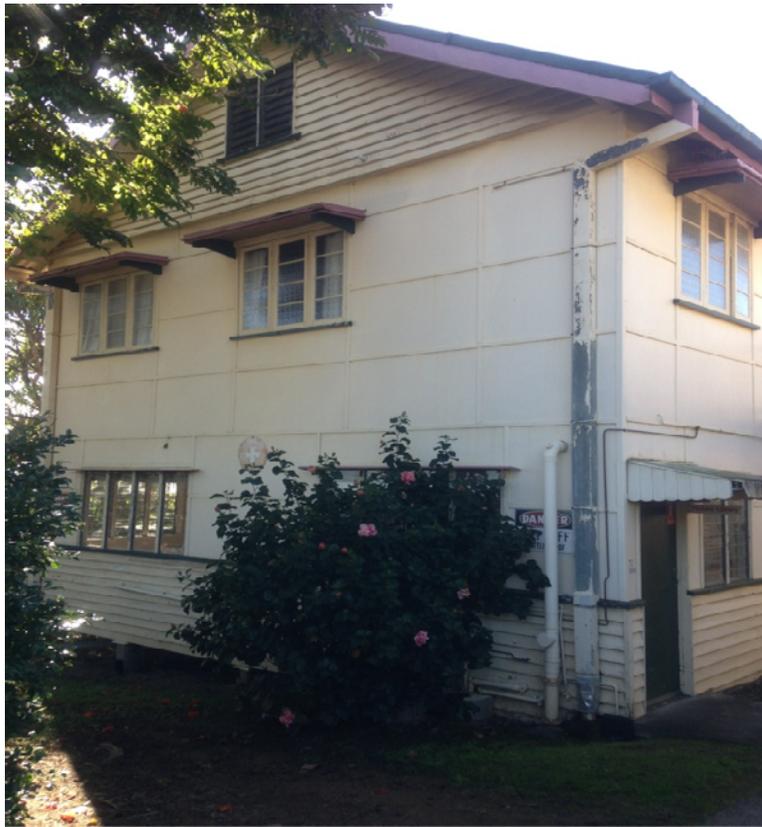
The northern building has historically been used for accommodation, picture library, and general maintenance and communal areas. The two story building was generally in poor condition with peeling paint, fibro cement sheeting and corrugated asbestos cement sheeting. The ground floor was raised with concrete stumps forming a void beneath the northern building between ~500mm to 100mm above the underlying soil. The space formed underneath the building contained various items of debris including a 40L drum, plastic containers, building off-cuts and fragments of asbestos containing materials. The fragments of asbestos observed were generally in poor condition and lying on the soil surface.

Photograph 2 – Northern Building containing closed accommodation facilities.

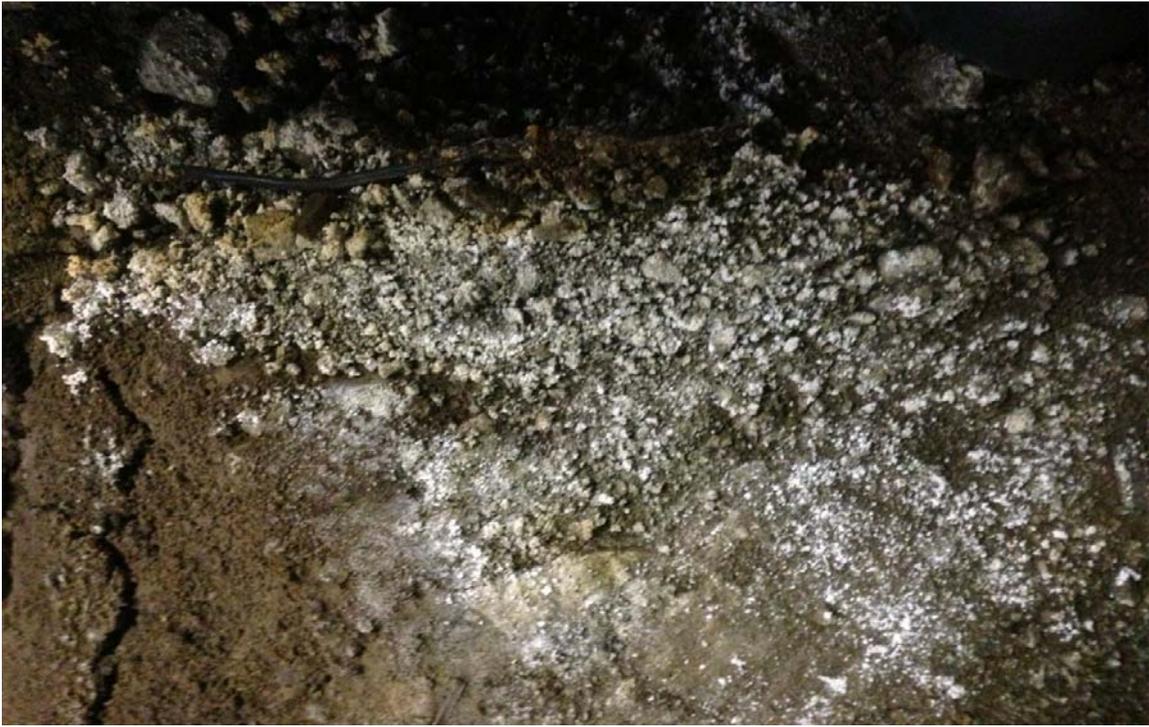
- Asbestos fibres were detected in soil samples SS01 (0.007% weight/weight) and SS02 (0.02% weight/weight). These concentrations of asbestos fibres are above the recommended investigation level for fibrous asbestos or asbestos fines in soil for all site uses. Therefore, the detected concentrations have the potential to impact on current and future site users.

Photograph 3 – Salt crusting beneath southern building.

Additional investigations are recommended to provide increased sampling densities to allow for hotspot detection and further delineation of contaminants present. The investigations should be conducted in accordance with the following.

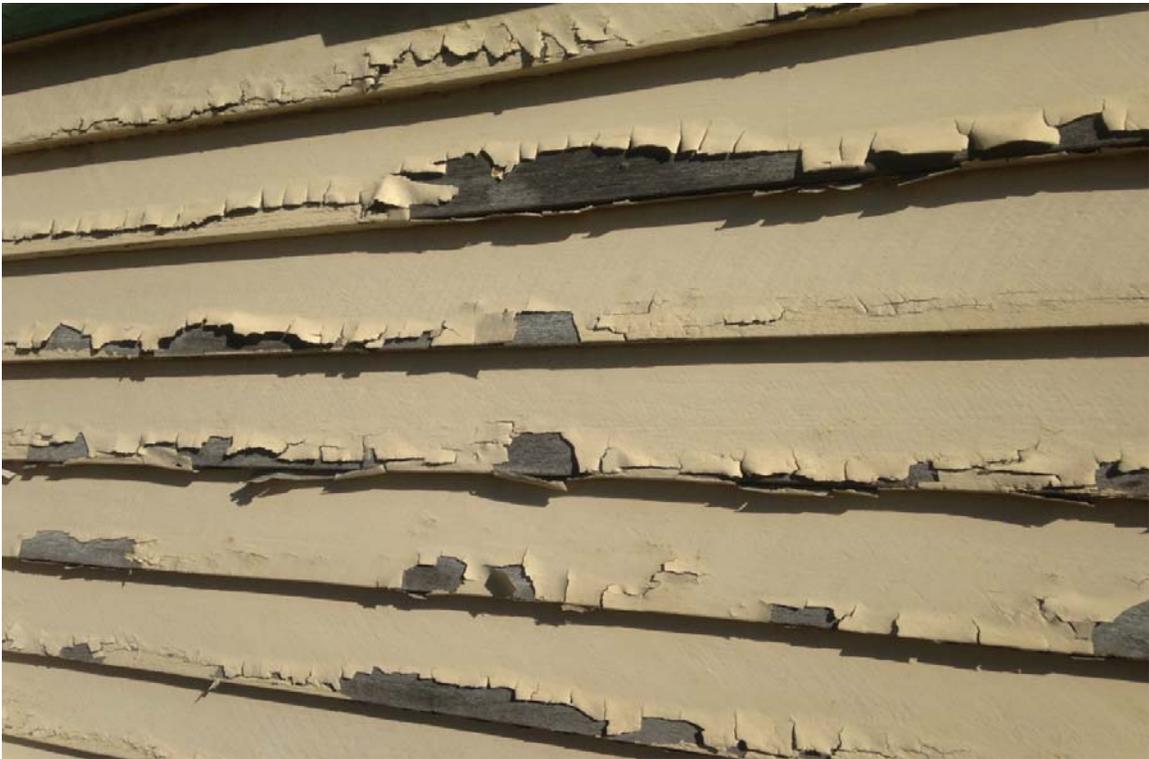
Photograph 4 – Example of peeling external paint.

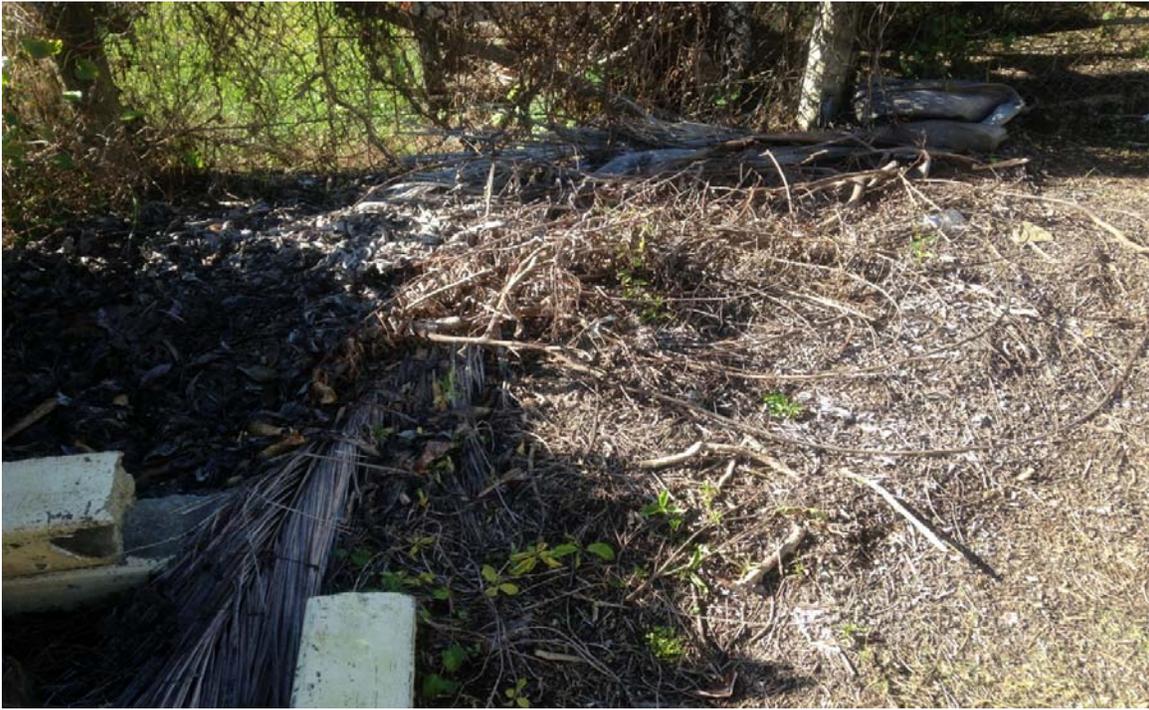
Areas external to the buildings were used for car parking, driveway, washing line, wheelie bin storage, footpaths and some limited landscaping at the street frontages. A single piece of asbestos containing material (~10cm x 7.5cm) was noted at the front of the northern building at the base of an African Tulip tree. The north east corner of the site was used for the storage of domestic type wheelie bins and what appeared to be a vegetation compost pile. Some recent herbicide use appears to have been undertaken in this back corner to control weeds.

Photograph 5 – Stressed vegetation in the north east corner of the site.

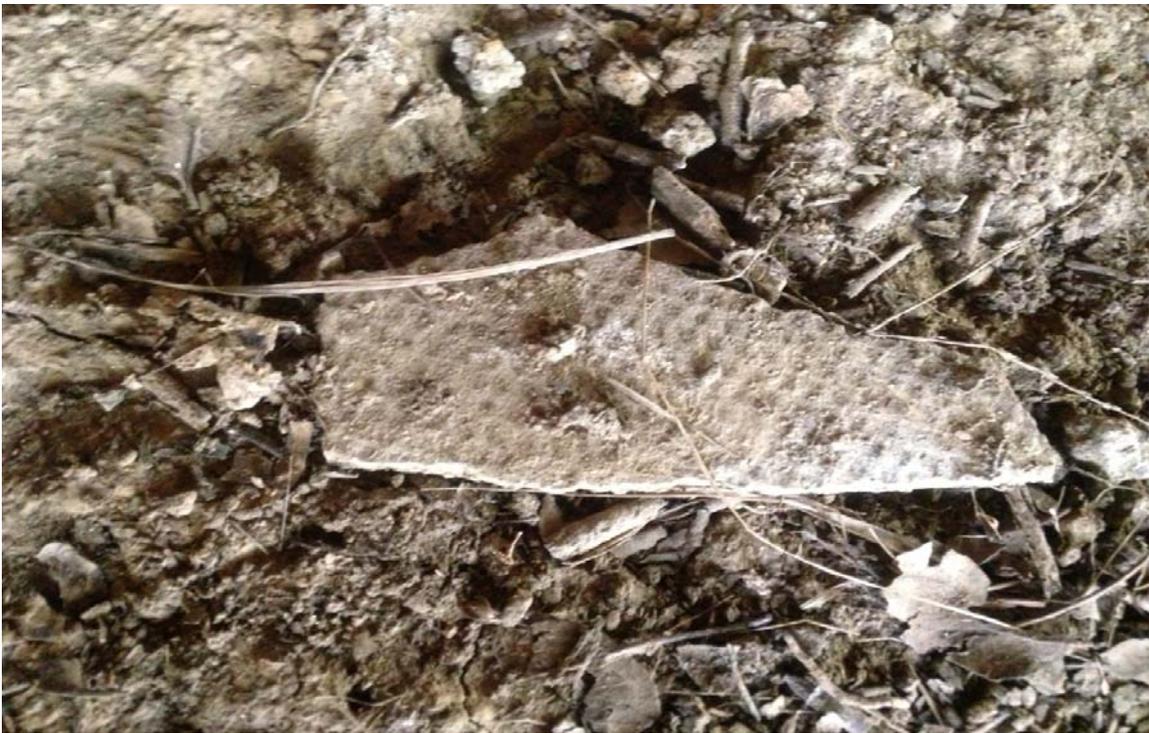
In addition to the asbestos containing materials observed on the site's surface, asbestos fibres were identified in the soil at concentrations that could potentially impact current and future site users. Access to and disturbance of the exposed soils beneath and immediately surrounding the site's buildings should be restricted until further investigations, mitigation measures and or remediation works are completed.

Photograph 6 – Example of Asbestos containing material fragment.

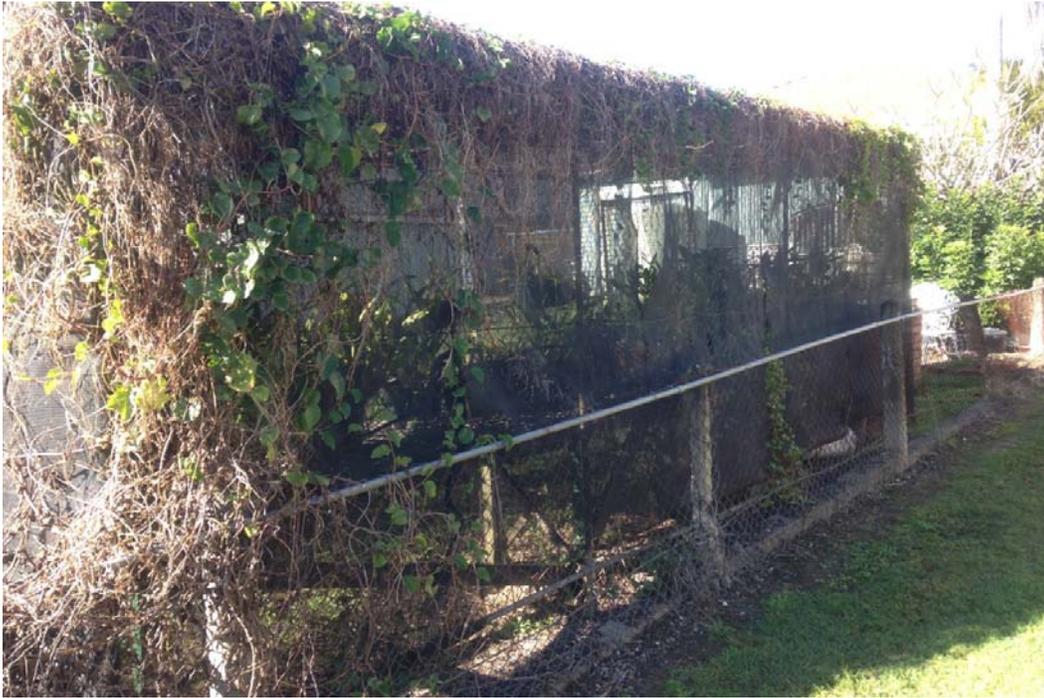
Photograph 7 – Orchid shade house on property to east.

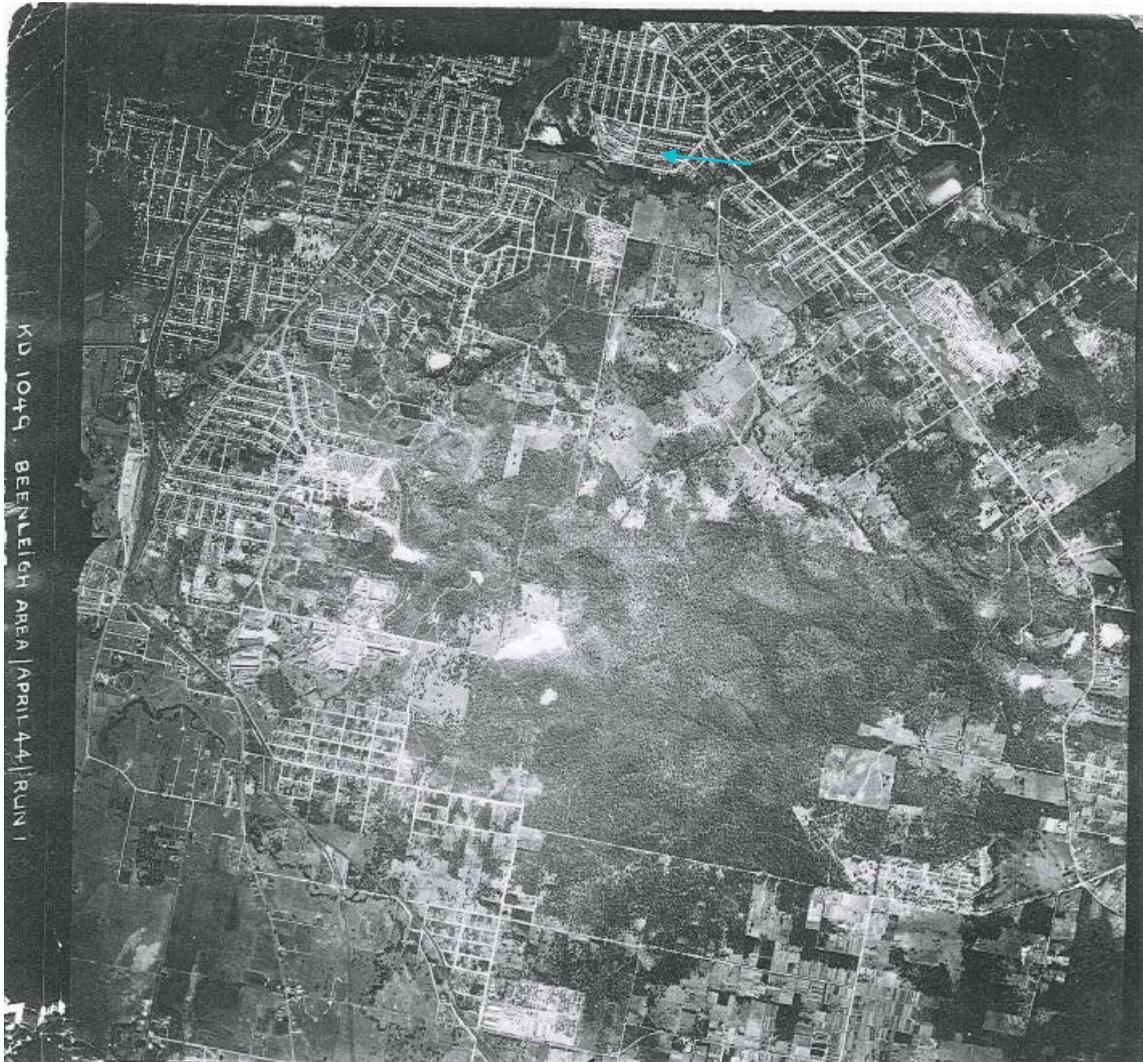
Aerial Photograph 1: 01/04/1944 Run 1. Frame 346. Scale 1:33800

Year	Title of Photography	Scale	Comments
1944	Beenleigh Run 1. Frame 346.	1:33,800	Note the scale of the aerial photograph prevents site detail to be seen clearly. The site and immediately surrounding properties were observed to be developed in the 1944 photograph. However it is possible the buildings present were different to the current buildings. Properties to the north, east and south appeared to be residential and the property on the west of Newdegate Street appeared to be an early configuration of the Greenslopes Hospital.
1955	Beenleigh Run 1. Frame 26.	1:25,000	The site appeared to support the current two buildings. Quarry/mining operations (quartzite mine) was visible to the west of the Greenslopes Hospital.
1968	Beenleigh Run 1. Frame 169.	1:22,900	As per the 1955 photograph.
1978	Beenleigh Run 1. Frame 4044.	1:25,000	Site and immediately surrounding properties as per the 1968 photograph. To the west of the Greenslopes hospital the South East Freeway is visible and mining operations appear to have ceased.
