**Asbestos Management  
Plan and Register for  
114 Newdegate Street  
Greenslopes**

Our Reference 019DVA01

**13 October 2019**

We are pleased to be able to supply you with the Asbestos Management Plan and Register of our inspection of 114 Newdegate Street Greenslopes

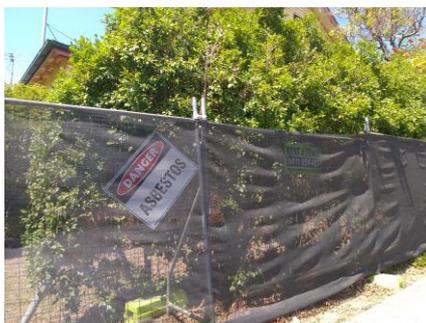
Therefore on this site signs have been installed at the perimeter fencing as shown below –

In these buildings if the roofing is to be removed and the sites remediated but other asbestos containing materials are to remain then we would recommend installation of this sign in both buildings at the entrances and introduction of the Asbestos Register and Management Plan as part of the site induction process.
