**Asbestos Management
Plan and Register for
114 Newdegate Street,
Greenslopes.**

Australian Red Cross Society

4 February 2015

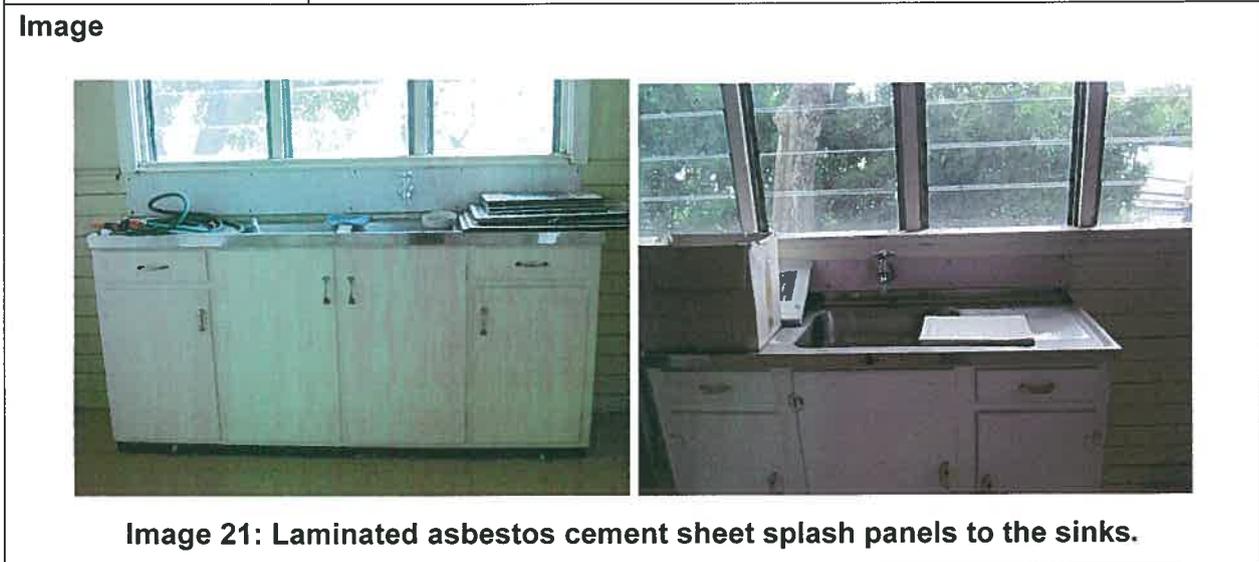
Site: 114 Newdegate Street, Greenslopes							
Competent Person: Brian Sketcher							
Date of Identification: 21st January 2015							
Location	Level	Room		Item		Product	
Internal	Ground	Former Library		Laminated panels		Asbestos cement sheet	
Sealed	Condition		Friability	Access	M2	Sample No.	Image No.
Yes	Good		Non	A2	2	Similar to sample RX - 08	21
Comments	The sink backing panels are constructed of laminated asbestos cement sheeting.						
Recommendations	Avoid damage and abrasion. Remove if dismantling, structural alterations or demolition is to be carried out in this area. Reassess at least every five years or prior to renovation or demolition work. Label appropriately as per State Government Guidelines and the Code of Practice.
